7. RECOMMENDED PLAN

The Recommended Plan is Alternative 2C: Eastern Diversion with Southern Riffles. A drawing of the Recommended Plan can be found on plate 7. This plan consists of dredging 15 acres, building a diversion berm to reroute the river along the eastern diversion route, excavating the eastern diversion channel for additional conveyance, adding three riffle structures at the southern end of the new channel, and enhancing existing wetlands with dredged material.

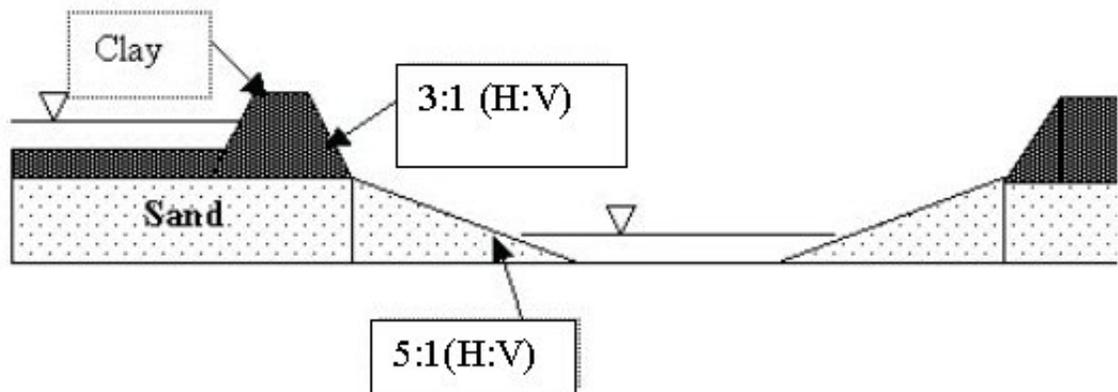
Figure 7.1. Schematic of proposed channel slopes.

The diversion berm would be constructed from the cohesive material taken from the borrow/CDF area. The berm would be constructed with 3:1 (H:V) sideslopes. However, when the channel is excavated, it would cut through the existing clay layer to the sand layer underlying the site. At this transition, the sideslopes would be shaped to 5:1 (H:V) to lend stability to the slopes. Bedding stone and riprap would be placed on these slopes to prevent erosion from the channel velocity. Figure 7.1 illustrates the existing conditions with the channel excavation. Refer to plate F-9 for the stability analysis of this system.
