**DETAILED PROJECT REPORT  
WITH ENVIRONMENTAL ASSESSMENT**

**SECTION 205 FLOOD DAMAGE REDUCTION STUDY**

**MAD CREEK  
MUSCATINE, MUSCATINE COUNTY, IOWA**

**APPENDIX C  
GEOTECHNICAL CONSIDERATIONS**

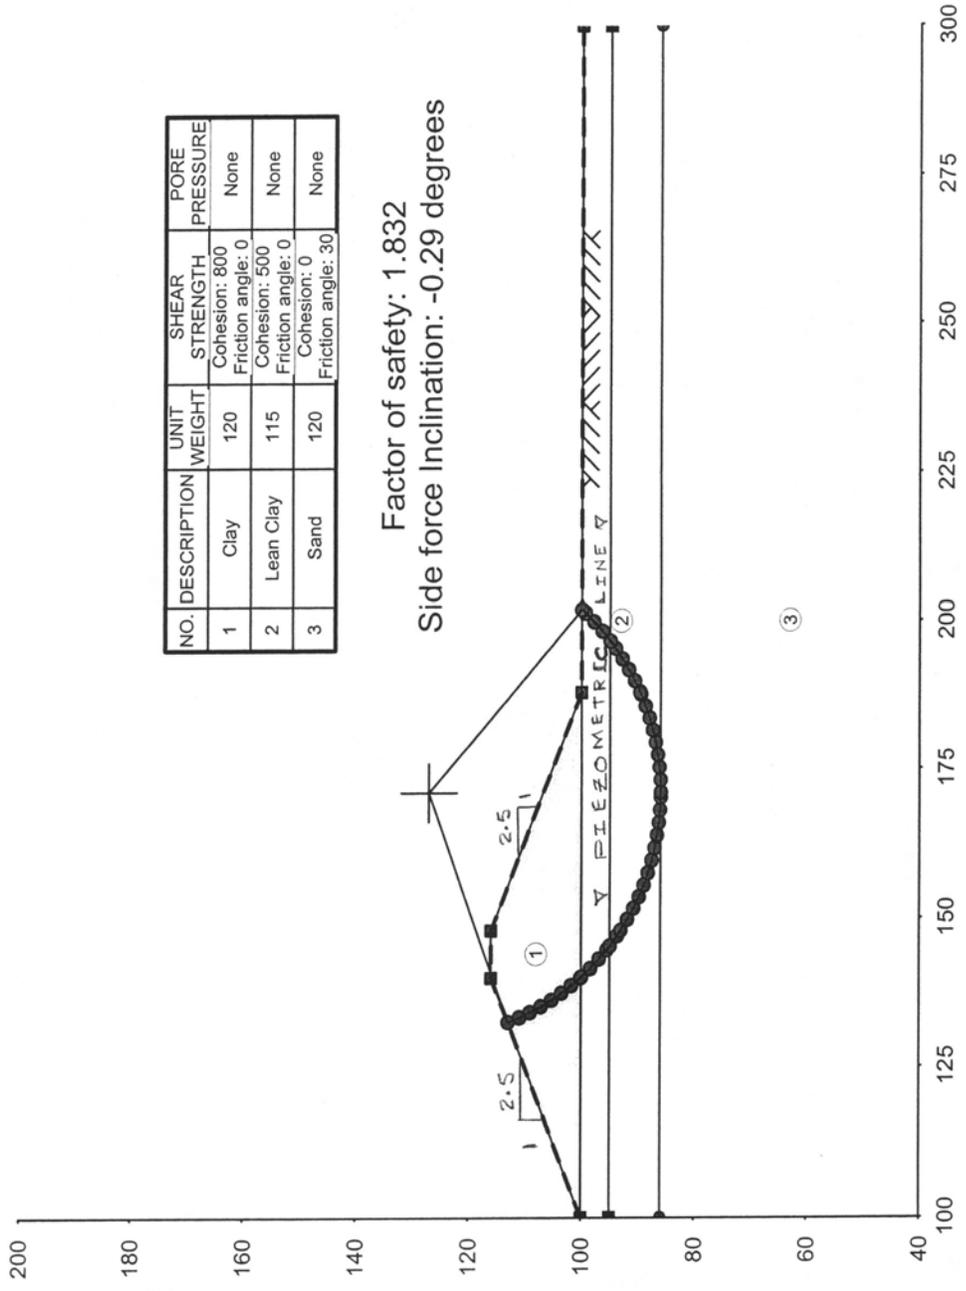
Mad Creek LFP - Section 205 - Stewart

Date: Wed Aug 08 2001  
 Filename: C:\WINUT4\MadCreek.UT4  
 Time: 06:25:11

Successive trials of various sliding surfaces were analyzed, and determination of the critical failure arc having the lowest safety factor was made. The summary of the slope stability analyses for critical sections and the solutions of the most critical arcs appear on plates C-1, C-2, and C-3. The

computed minimum safety factors were found to be 1.83 at Station 12+00, 1.92 at Station 21+50, and 1.63 for the channel improvement. These exceed the 1.3 that is required by EM 1110-2-1913, *Design and Construction of Levees*, dated March 31, 1978. Therefore, no slope stability problems are expected. A sudden draw down loading and seepage conditions were not evaluated since high water levels will be of such short duration that saturation of compacted embankment cannot occur.

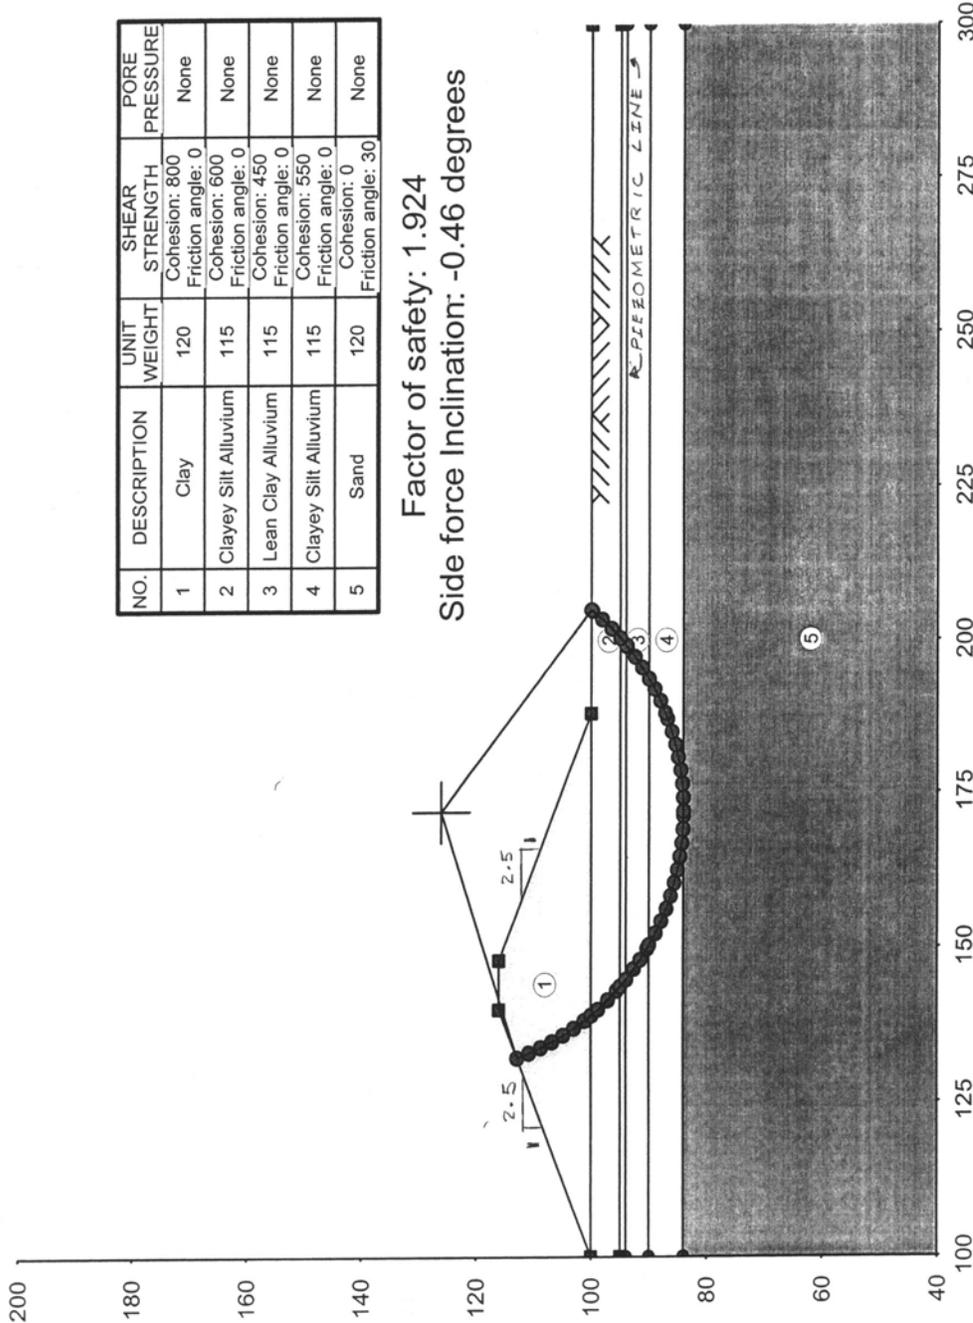
Mad Creek LFP - Section 205 - Stewart

NO.	DESCRIPTION	UNIT WEIGHT	SHEAR STRENGTH Cohesion: 800 Friction angle: 0	PORE PRESSURE
1	Clay	120	Friction angle: 0	None
2	Clayey Silt Alluvium	115	Friction angle: 0	None
3	Lean Clay Alluvium	115	Friction angle: 0	None
4	Clayey Silt Alluvium	115	Friction angle: 0	None
5	Sand	120	Cohesion: 0 Friction angle: 30	None

Date: Wed Aug 08 2001  
 Filename: C:\WINUT4\MadCrk.UT4  
 Time: 07:01:52

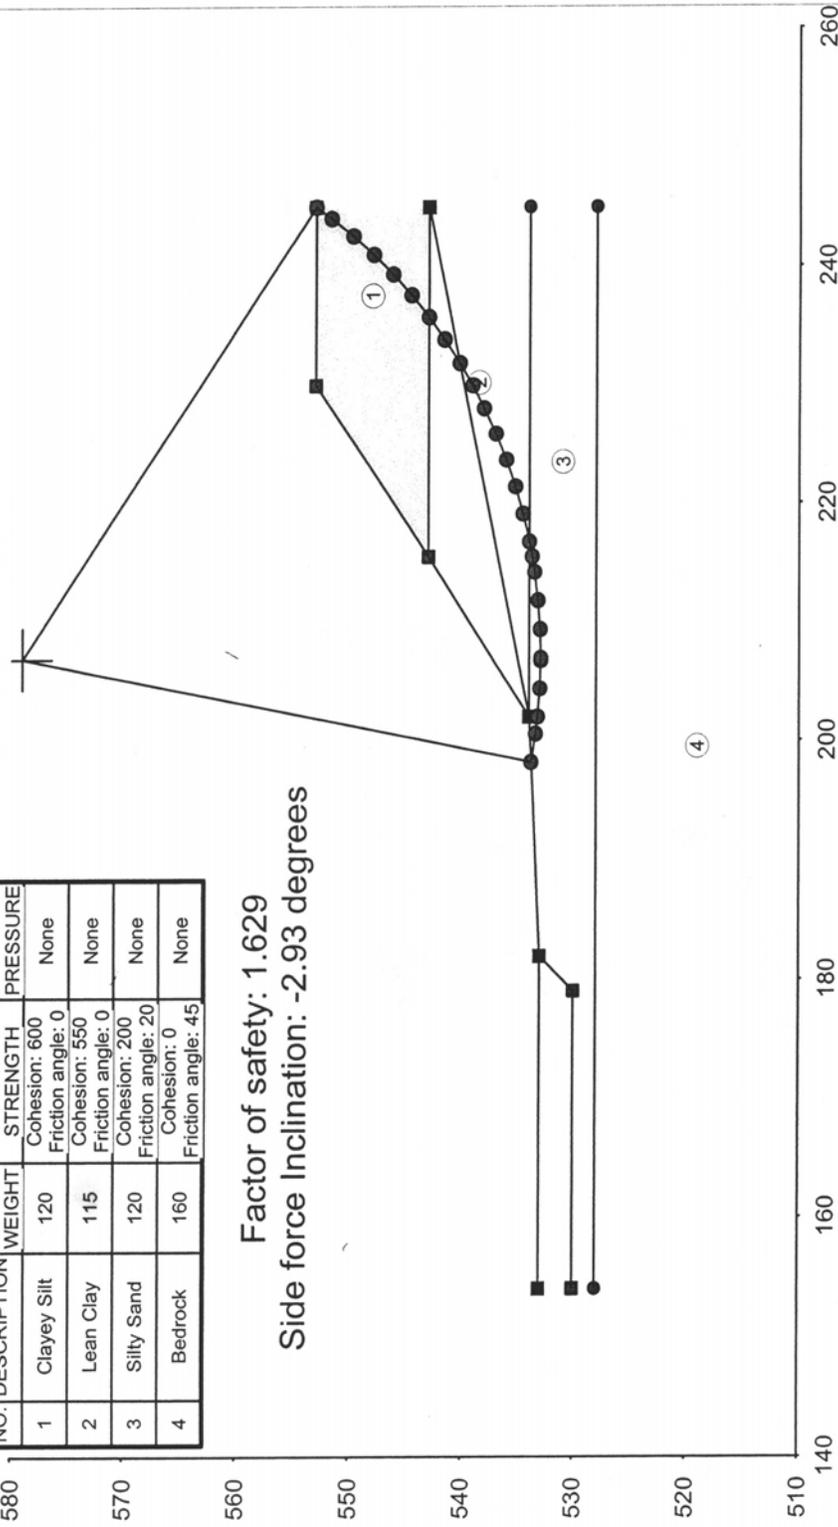
Mad Creek LFP - Section 205 - Stewart

NO.	DESCRIPTION	UNIT WEIGHT	SHEAR STRENGTH	PORE PRESSURE
1	Clayey Silt	120	Cohesion: 600 Friction angle: 0	None
2	Lean Clay	115	Cohesion: 550 Friction angle: 0	None
3	Silty Sand	120	Cohesion: 200 Friction angle: 20	None
4	Bedrock	160	Cohesion: 0 Friction angle: 45	None

Factor of safety: 1.629  
Side force Inclination: -2.93 degrees
