# UPPER MISSISSIPPI RIVER RESTORATION

# PERFORMANCE EVALUATION REPORT

**BANNER MARSH**

HABITAT REHABILITATION AND ENHANCEMENT PROJECT

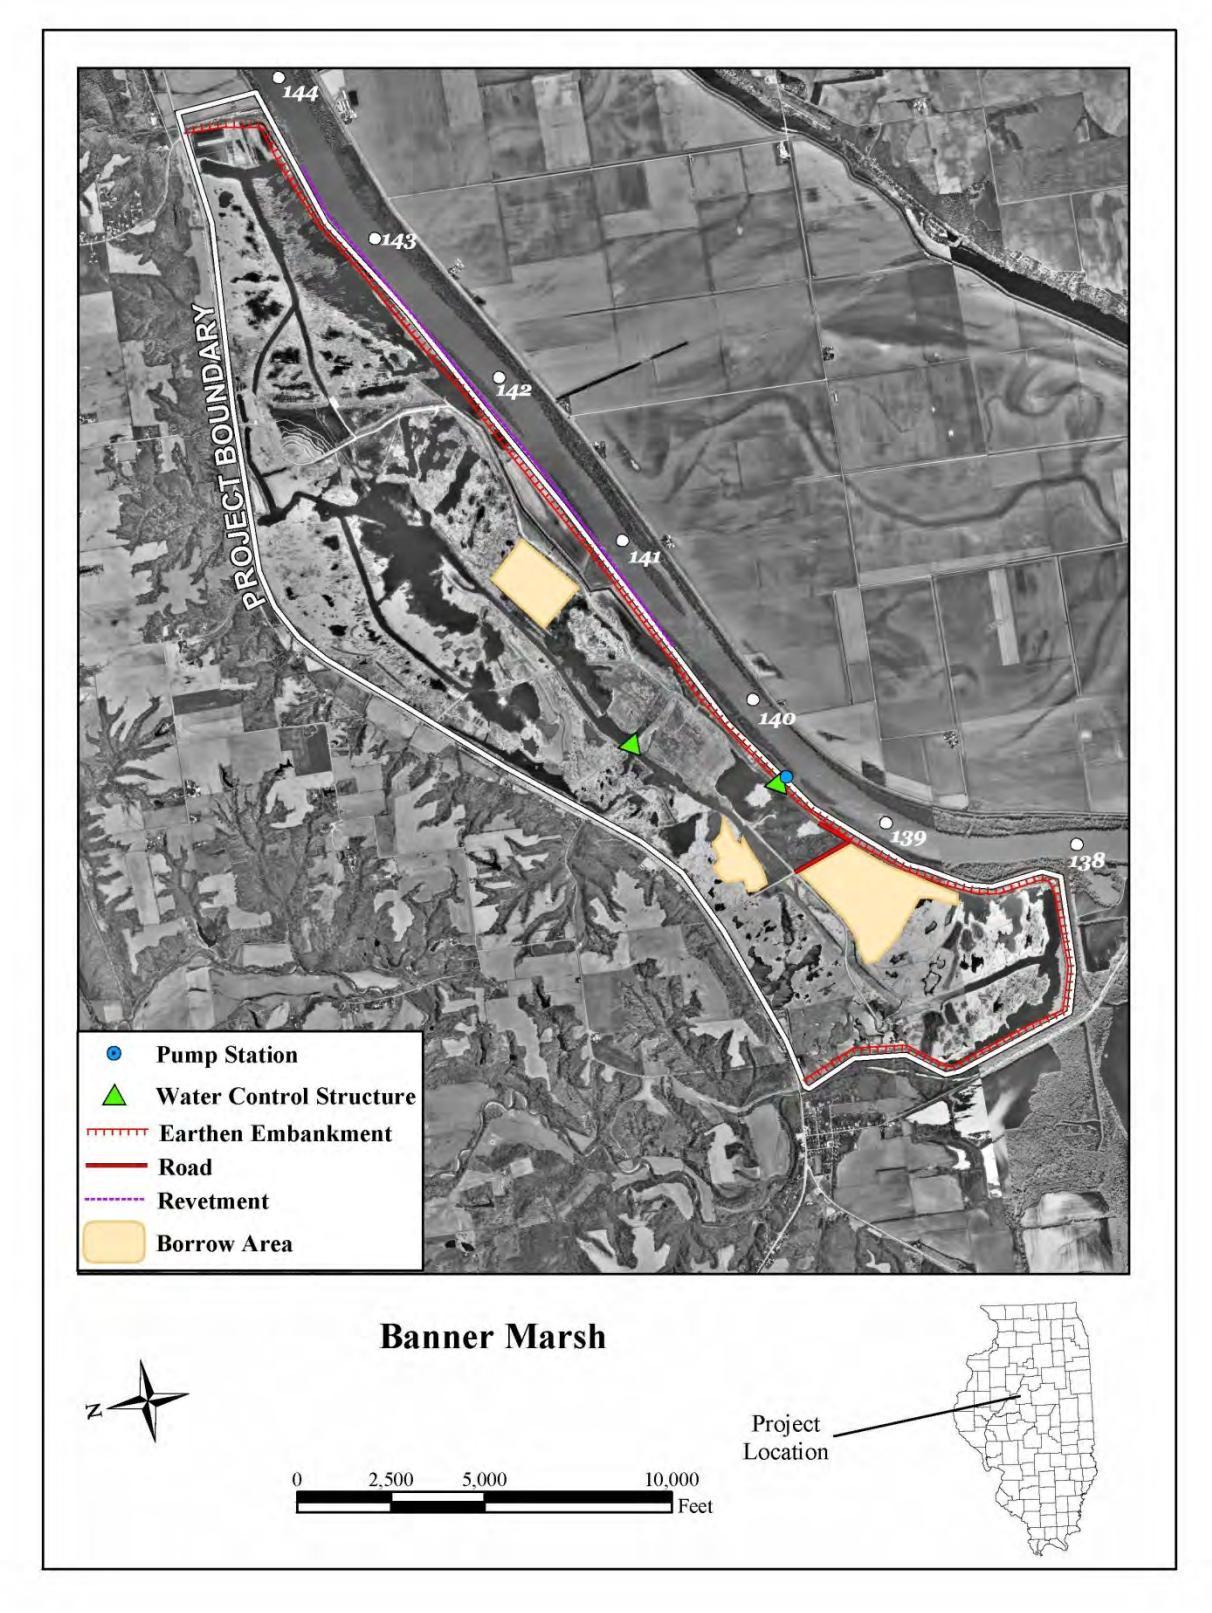
Figure 2. Banner Marsh HREP Project Features

Banner Marsh included a combination of littoral zone grading, levee and pump station repair, water control structures and prairie plantings (see Figure 2 for locations of measures). A detailed description of each of these measures is provided below.

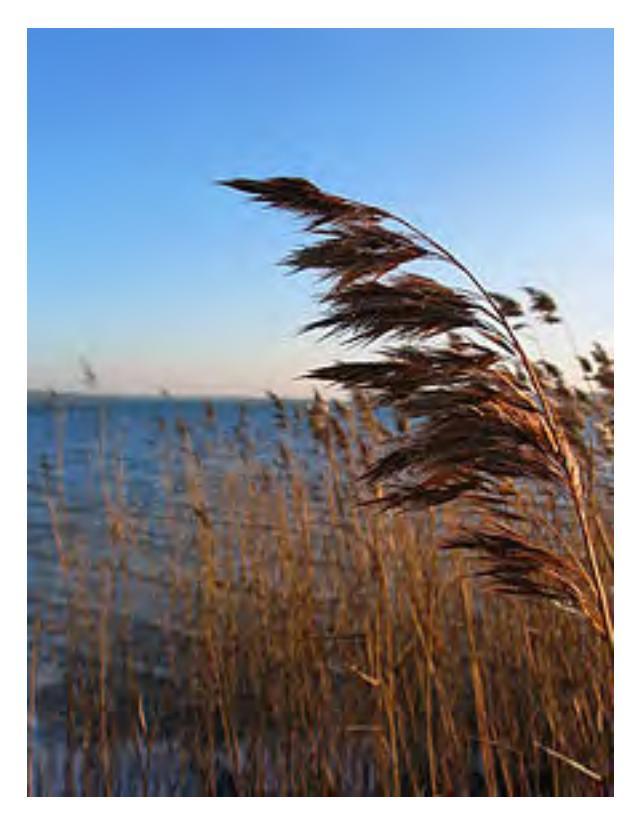
Photo 1. Phragmites australis

Phragmites (*Phragmites australis*) (Photo 1), an exotic plant, has gained a dominant foothold at Banner Marsh in many of the wetland areas near any open water. While the upland prairies are still intact, phragmites is found in the low areas near the prairies.

The invasive plant dilemma at Banner Marsh has a large impact on the HREP's overall goals. The phragmites and Eurasian watermilfoil dominance is out-competing the native vegetation. This is compounded by the reduction of the IL DNR's on-site management abilities in the last 10 years.

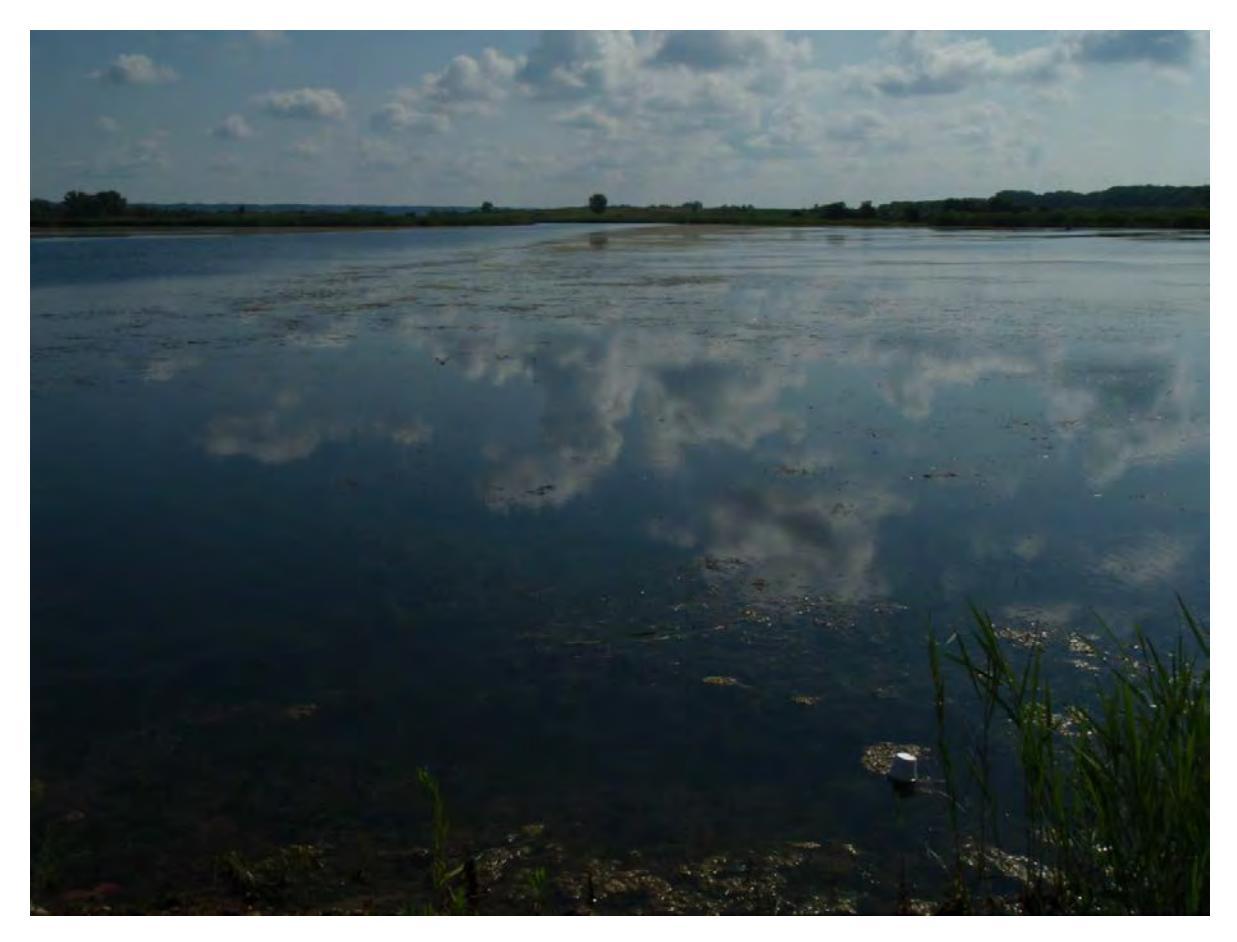
Photo 2. Large beds of water milfoil dominates the vegetation community in this borrow site.

Eurasian watermilfoil (*Myriophyllum spicatum*) (Photo 2) is another invasive plant. This is a rooted submerged aquatic plant. Milfoil starts spring growth sooner than native aquatic plants and can shade out these beneficial plants. When milfoil invades new territory, typically the native species diversity of aquatic plants declines. While some species of waterfowl will eat milfoil, it is not considered to be a good food source. Milfoil reproduces extremely rapidly and can infest an entire lake within two years of introduction to the system.

The project's borrow areas are dominated by Eurasian watermilfoil.

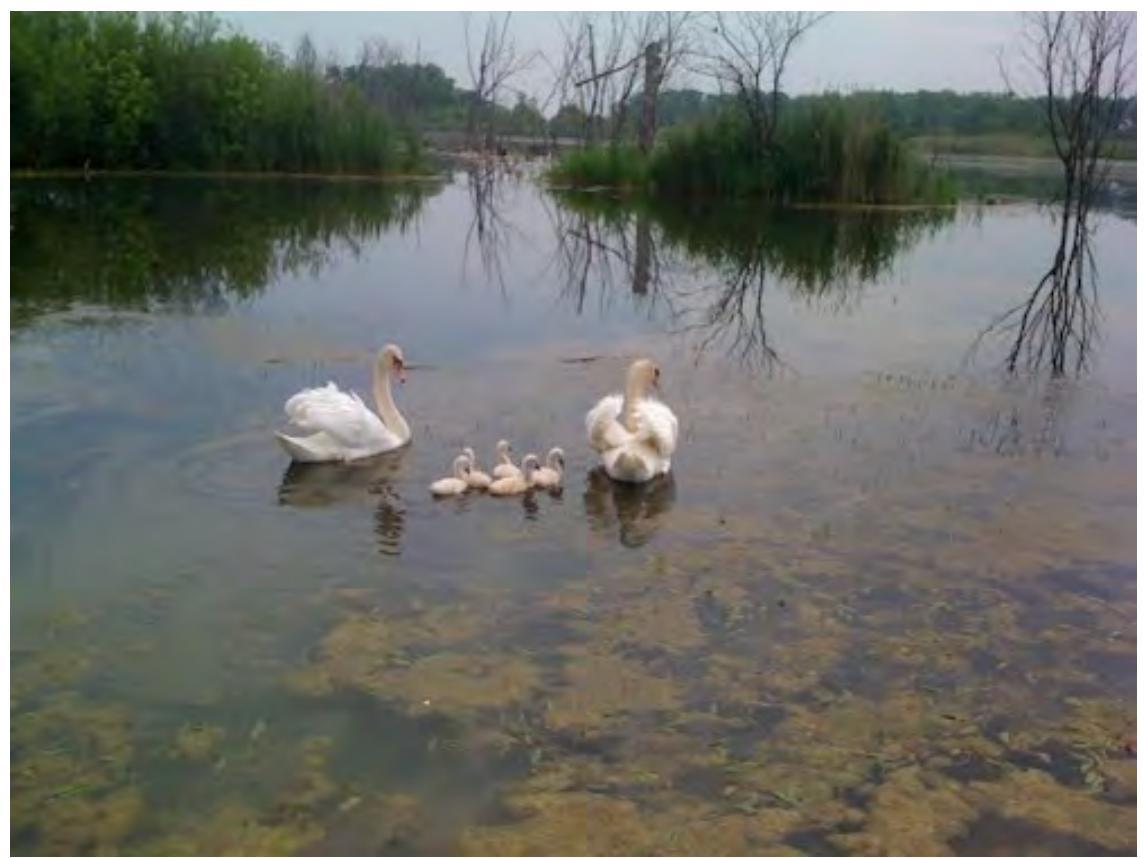
Photo 4. A mute swan family at Banner Marsh. Note the abundance of aquatic vegetation. Also note the phragmites in the background.

The post construction conditions in 2013 remain useful to waterfowl. Several sets of mute Swans (*Cygnus olor*) (Photo 4) were utilizing the borrow areas for nesting, rearing of young, and feeding. In 2012, a paper (Stafford, Eichholz and Phillips, 2012) was published studying the exotic mute swans impact to wetlands through degradation of submerged aquatic vegetation (SAV) communities. The study found above-ground biomass of vegetation did not differ between exclosures and controls; however, mean below-ground biomass was greater in exclosures (52.0 g/m<sup>2</sup>, SE0 6.0) than in controls (34.4 g/m<sup>2</sup> SE0 4.0)
