**Upper Mississippi River System Environmental Management Program****Fact Sheet****PIASA/EAGLE'S NEST ISLANDS RESTORATION AND WETLAND DEVELOPMENT****Pool 26, Mississippi River, Illinois**

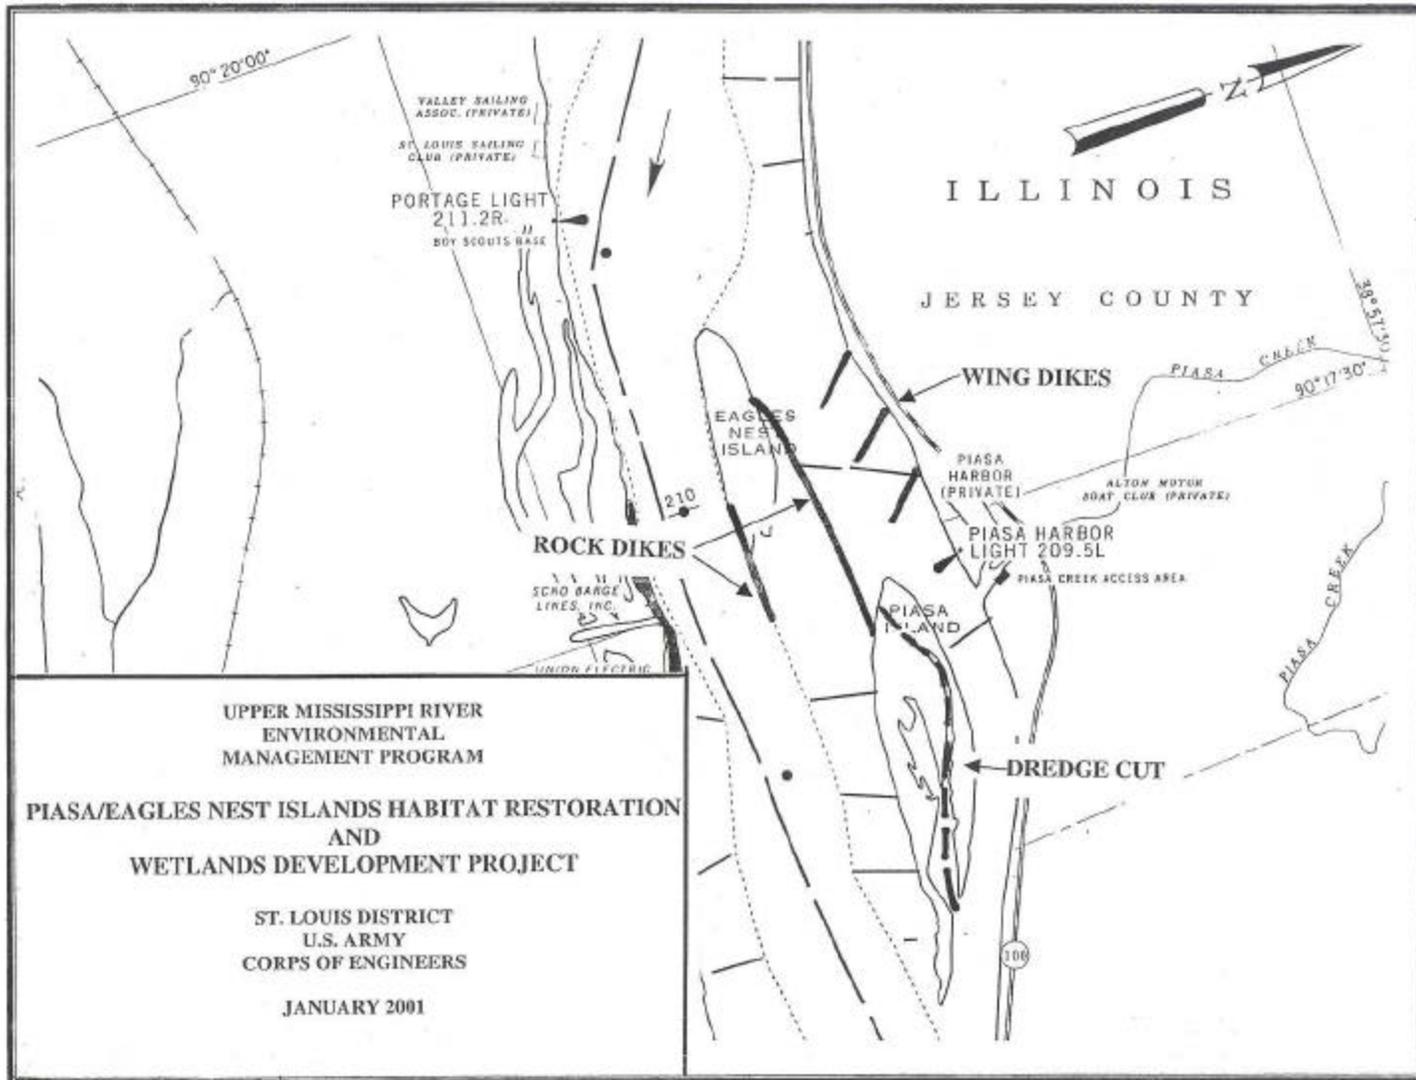
Project: The project consists of: (1) a side channel closure dike, (2) a trail dike, (3) a series of wing dikes, and (4) interior wetlands dredging.

The project includes a rock dike (4,800 feet long) extending from the middle east side shoreline of Eagle's Nest Island, to a point 300 yards south of the northern tip of Piasa Island, along that island's west bank. The dikes would tie-in to Piasa Island downstream of the entrance to the island's old interior channel. Dike diverted river flows would help to reestablish an interior channel. Initially the depth of the interior channel would be restored via dredging. The project would be designed to utilize river forces in a manner that would negate the need for repeat dredging during the project's life.

In addition, an 1,800 foot rock trail dike would extend southward from the southwest corner of Eagle's Nest Island. Also, three 1,000 foot long wing dikes would be placed off the west bank of the river to concentrate flows into the Piasa Island side channel.

Project Outputs: The placement of the dike from Eagle's Nest to Piasa Island would direct more flow into the island's side channel. With the addition of the wing dikes extending from the east bank of the river, there would be an increased concentration of flow into the side channel. Scour holes would develop at the tip of the wing dikes, and would serve to maintain the access to the side channel from the north. This would restore and maintain the side channel habitat through the island. Initially, dredging would be employed to reduce the interior's sediments accumulation.

Between the two islands, there is a large shallow flat. The placement of the dike should accelerate deposition in this area. Past experience has shown that during high flow events the overtopping of the dike would create a plunge pool behind the dike. Associated with this pool the water would scour an escape channel back to the river channel. The dike extending south of the south tip of Eagle's Nest Island would cause deposition to occur to east of the dike. A scour hole could be expected to develop on the tip of the dike. As deposition causes the area behind the dike to accrete the hinge point management of pool 26 would periodically expose these areas. The de-watering will allow the germination of moist soil and other wetland plants creating herbaceous wetland habitat.
