## **DEFINITE PROJECT REPORT/ ENVIRONMENTAL ASSESSMENT (SP-23)**

# **AMBROUGH SLOUGH HABITAT REHABILITATION AND ENHANCEMENT PROJECT**

**Pool 10  
Upper Mississippi River  
Crawford County, Wisconsin**

**December 2000**

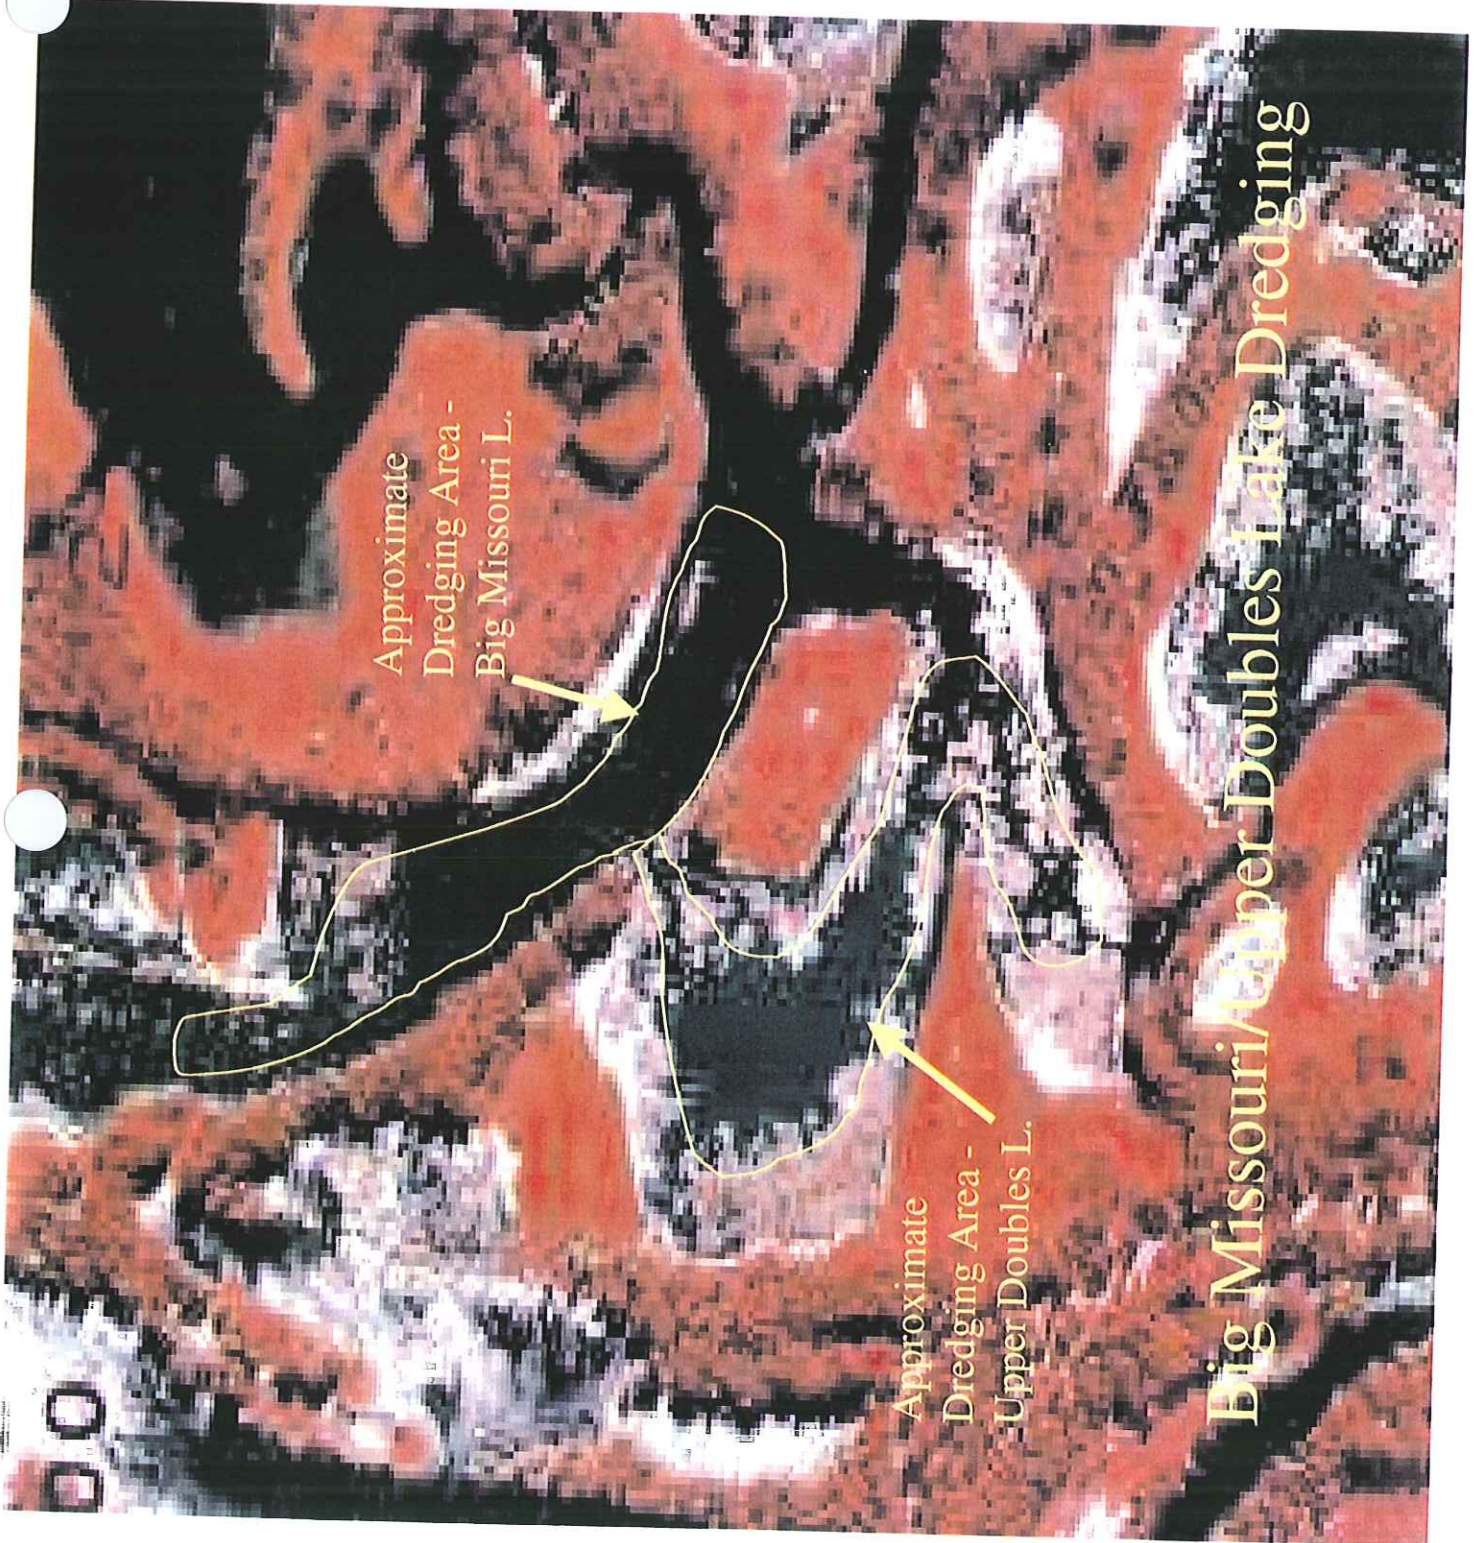
Big Missouri/Upper Doubles Lake Dredging

Approximate  
Dredging Area -  
Big Missouri L.

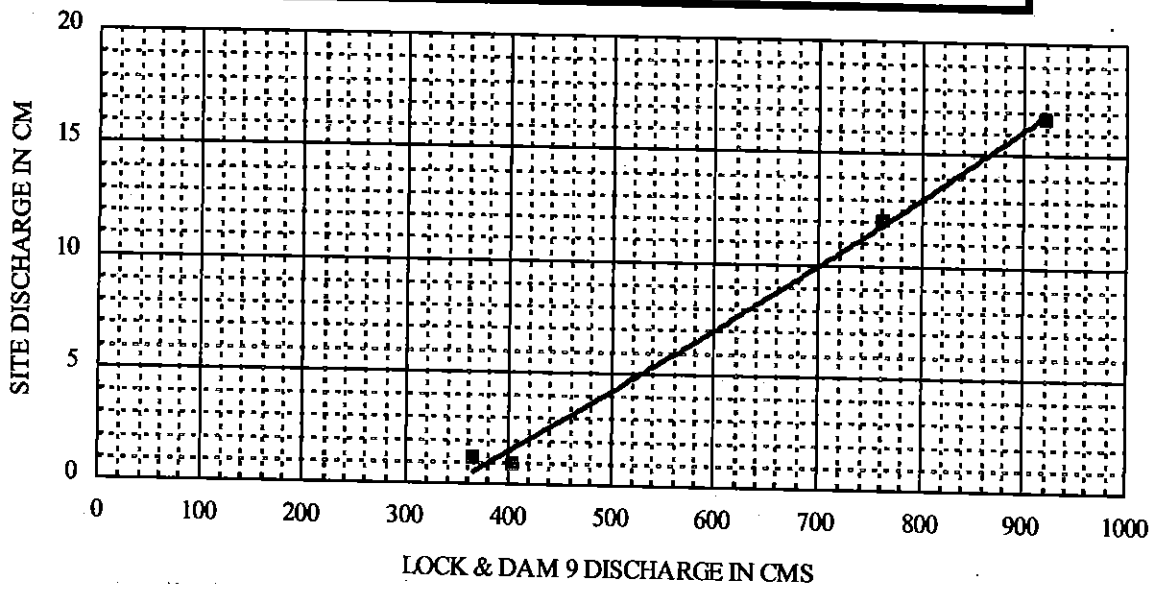
**CHART 3. POOL 10 - LOWER AMBROUGH SLOUGH**  
 WDNR WINTER DISCHARGES AT BOAT LANDING SITE
