UMRR HREP INSPECTION OF COMPLETED WORKS 2016

Spring Lake Habitat Rehabilitation and Enhancement Project (HREP)

Pool 13, Mississippi River Miles (RM) 532.5 to 536.0, Carroll County, IL

2013 Annual Inspection Report

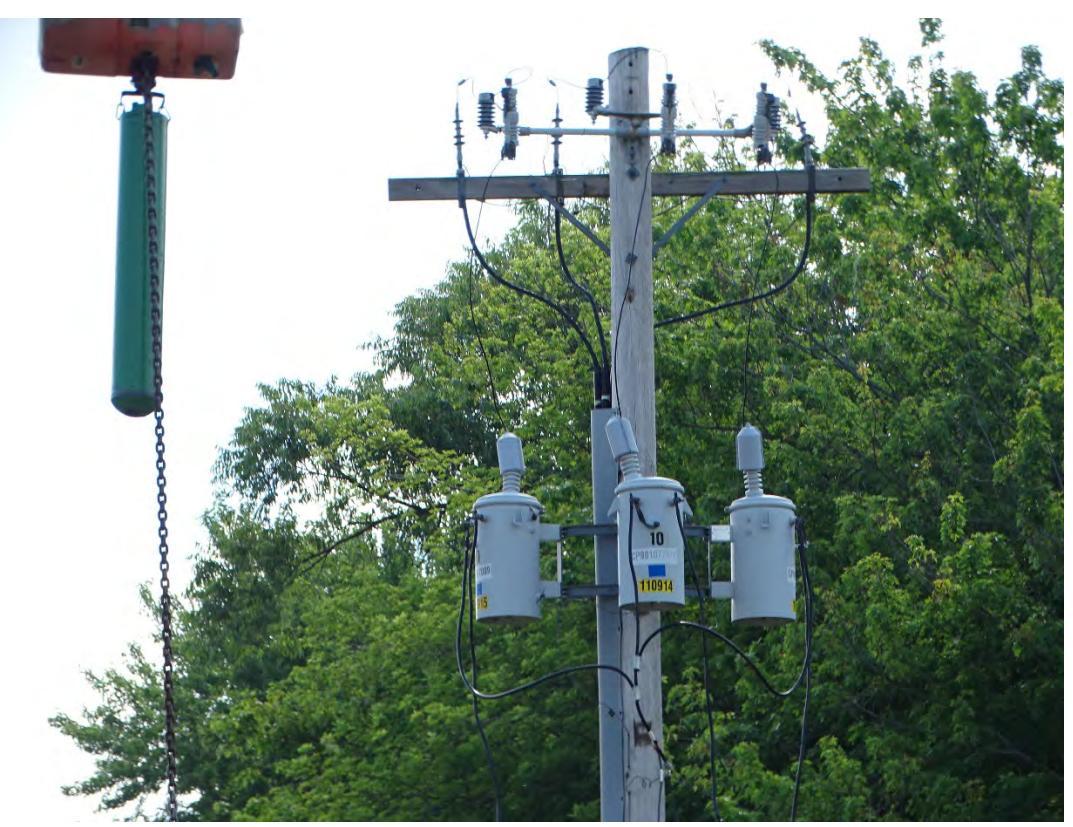
Photo 3: Pump station electrical equipment

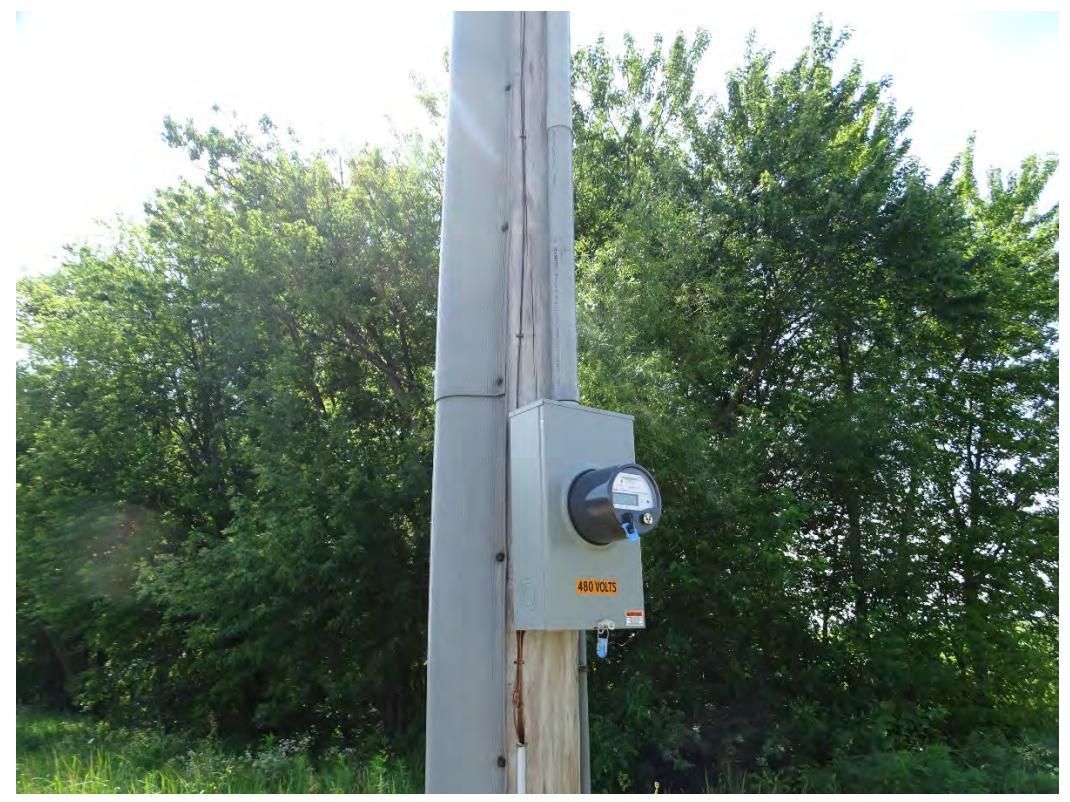
Photo 4: Pump station electrical equipment

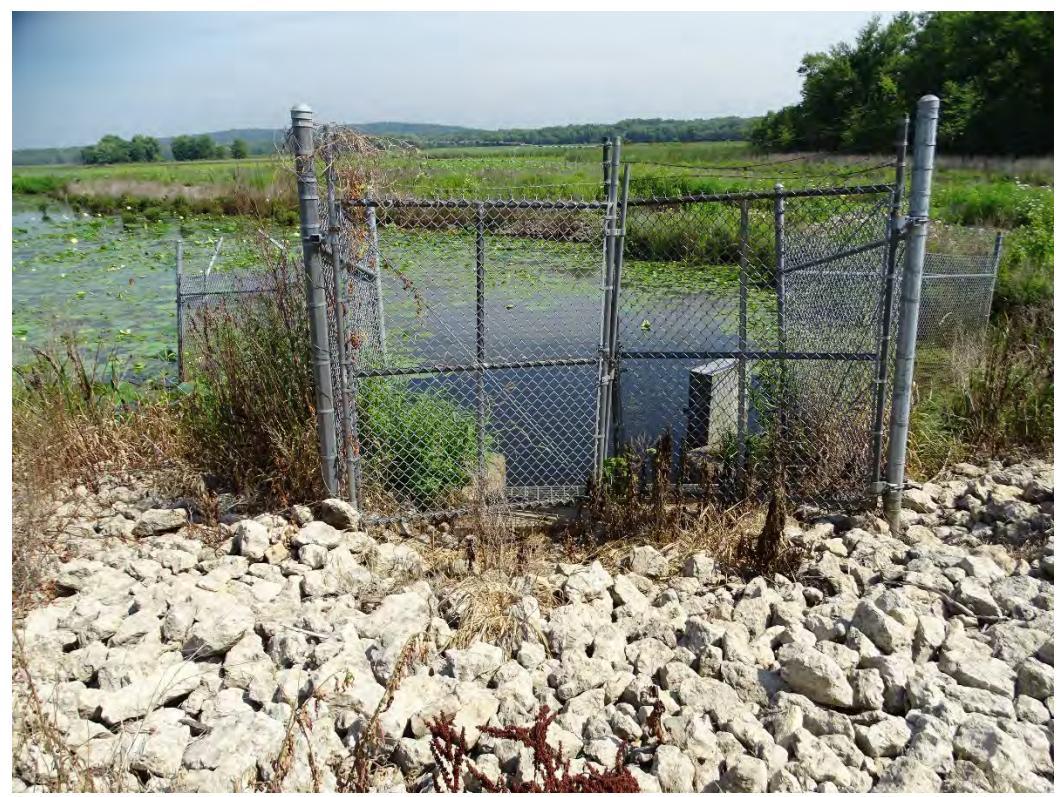
Photo 5: Pump station, interior side headwall

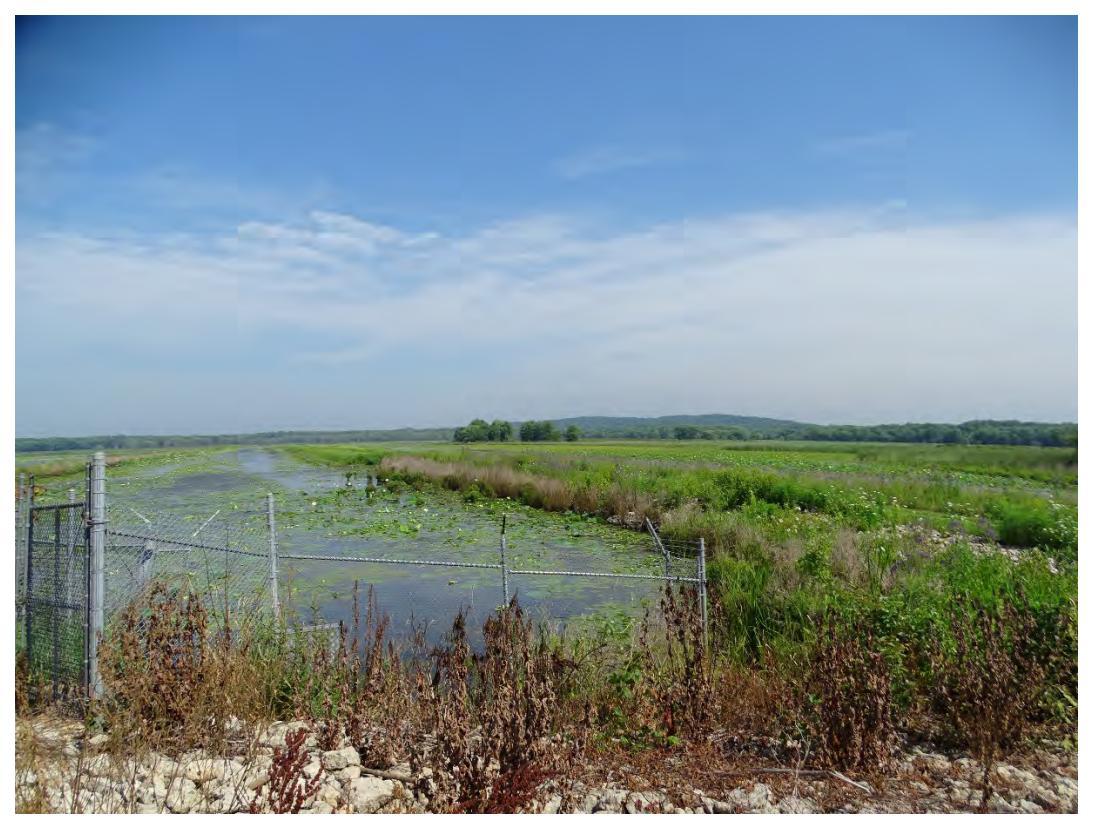
Photo 6: Pump Station, interior side headwall and interior Cell C

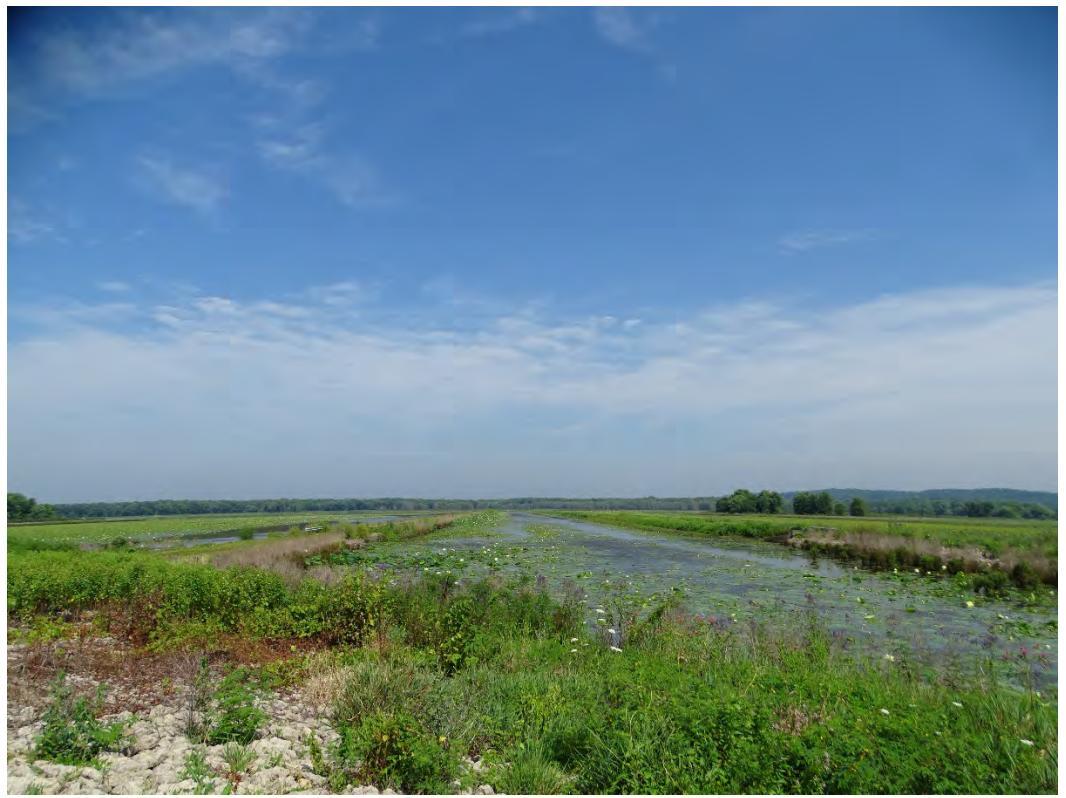
Photo 7: Interior Cell C, looking north from cross dike

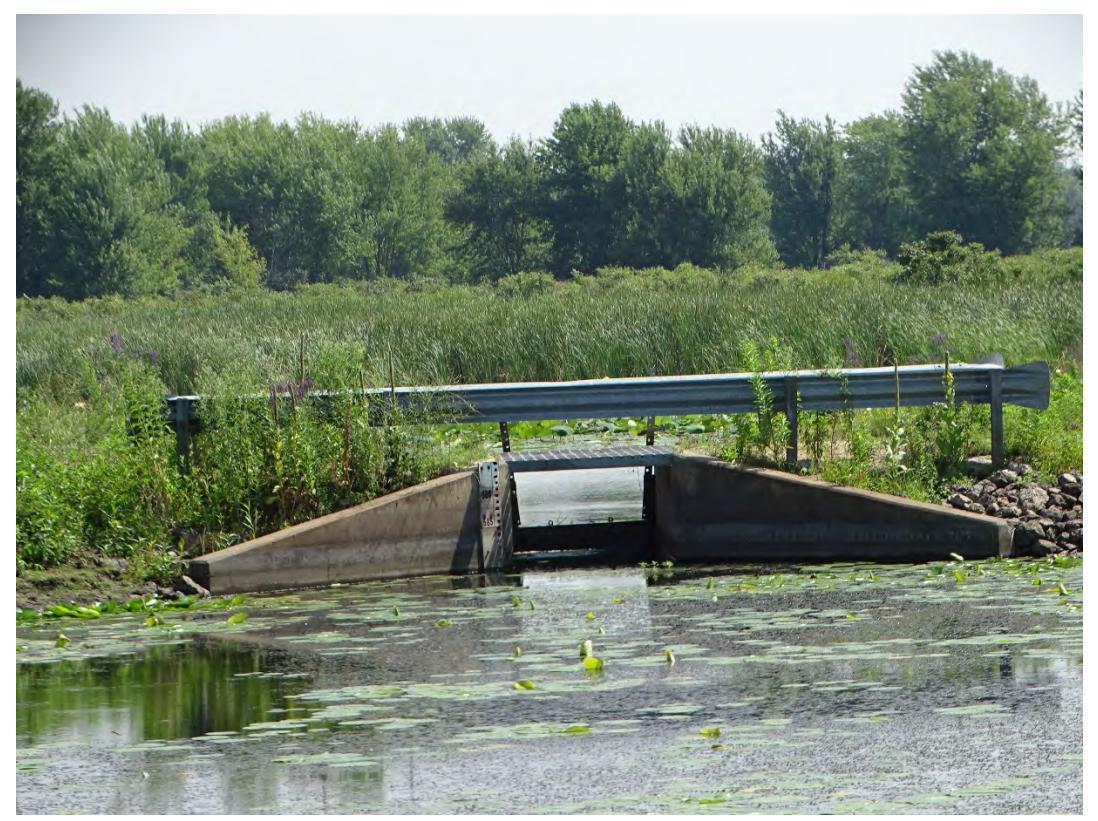
Photo 8: Stoplog structure C

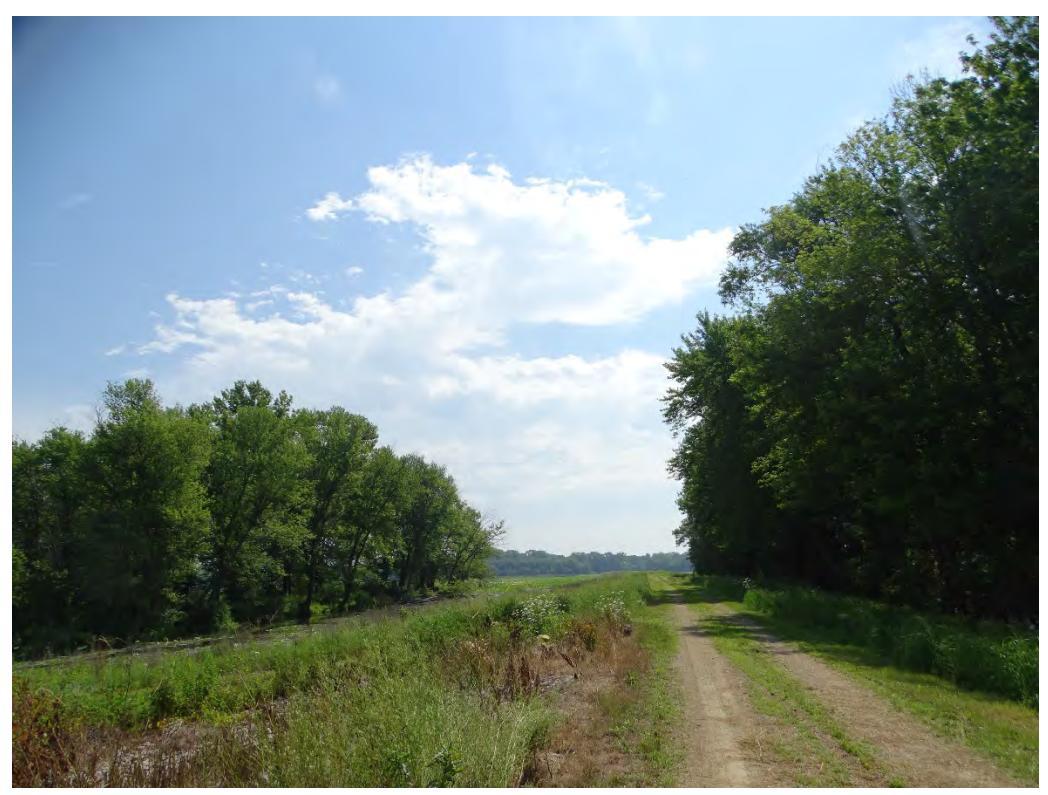
Photo 9: Cross dike roadway

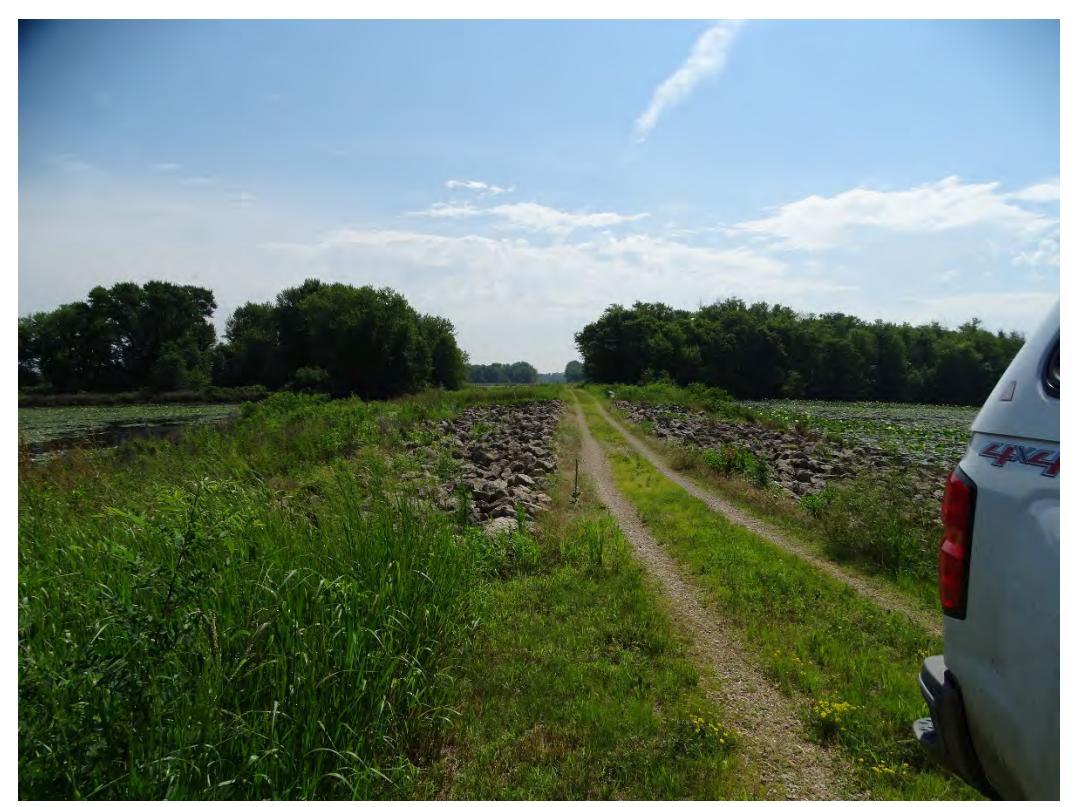
Photo 10: Cross dike spillway

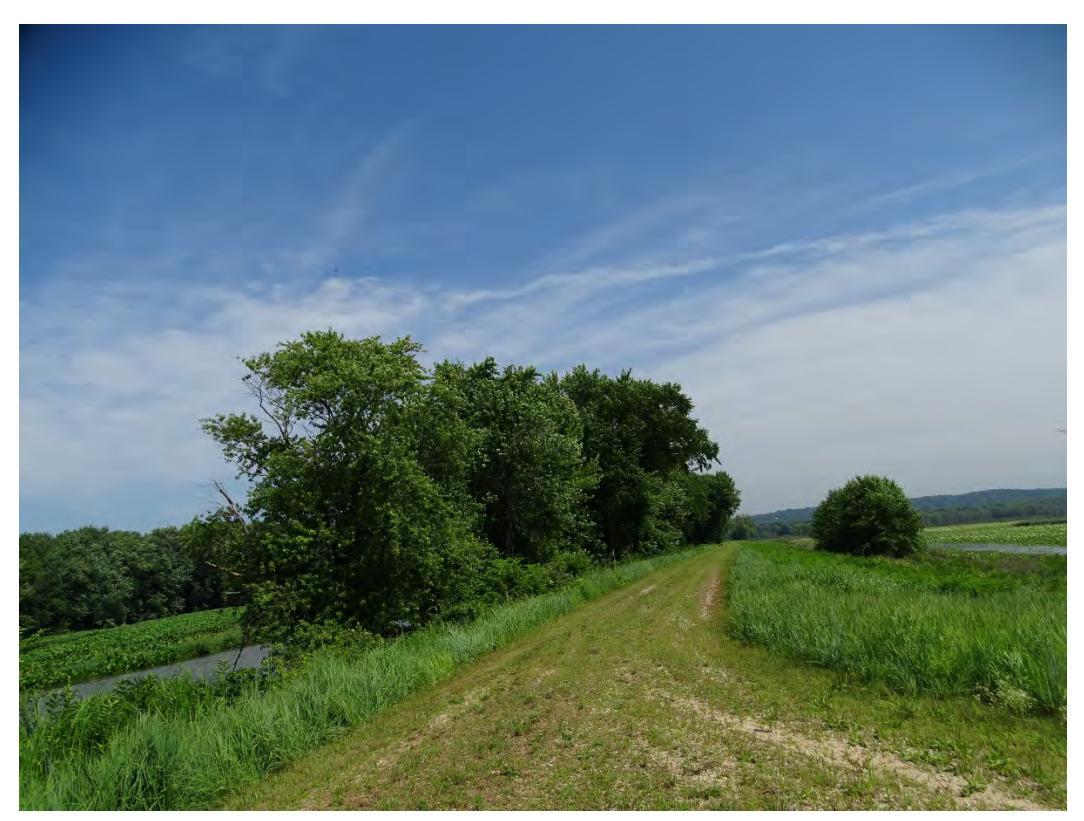
Photo 12: Perimeter levee and cross dike intersection, looking north

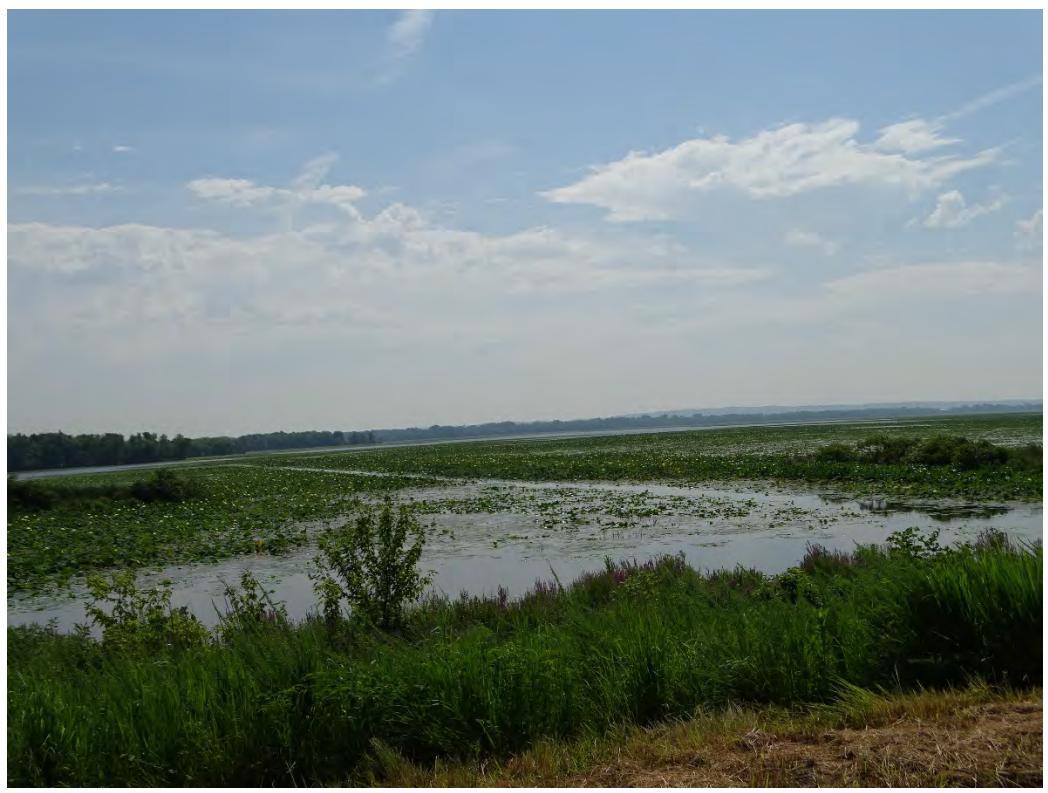
Photo 13: Inlet structure channel

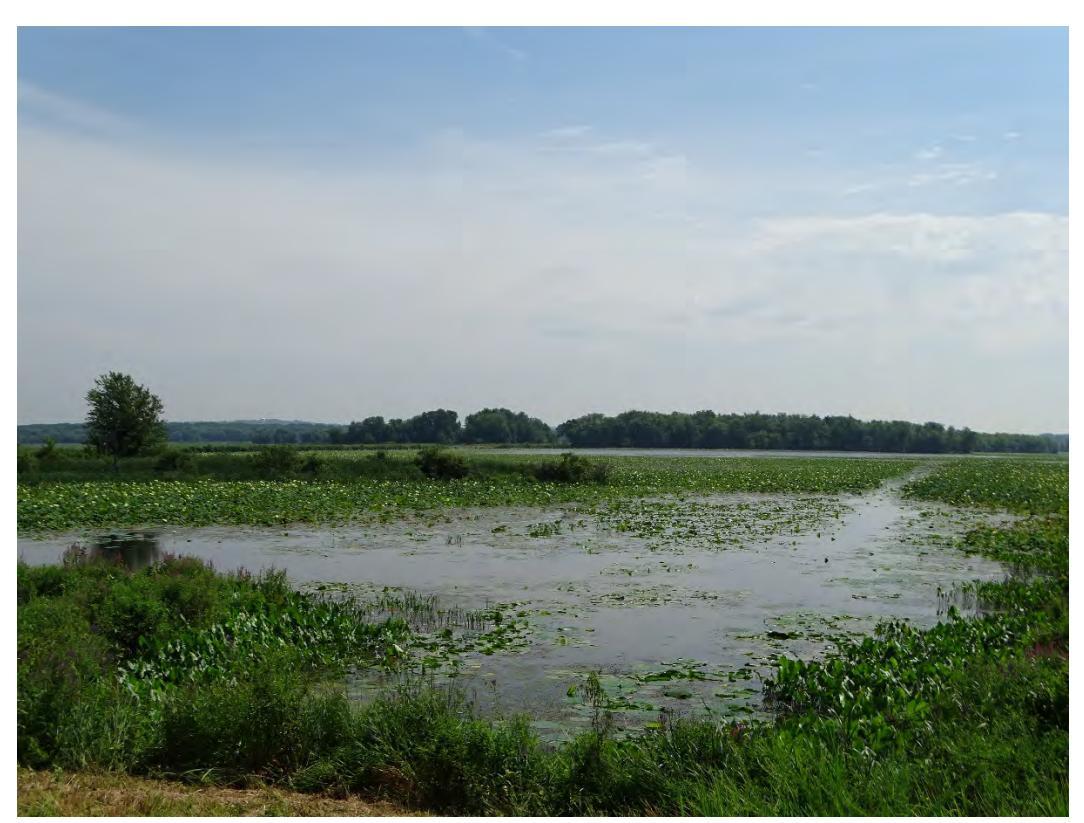
Photo 14: Inlet structure channel

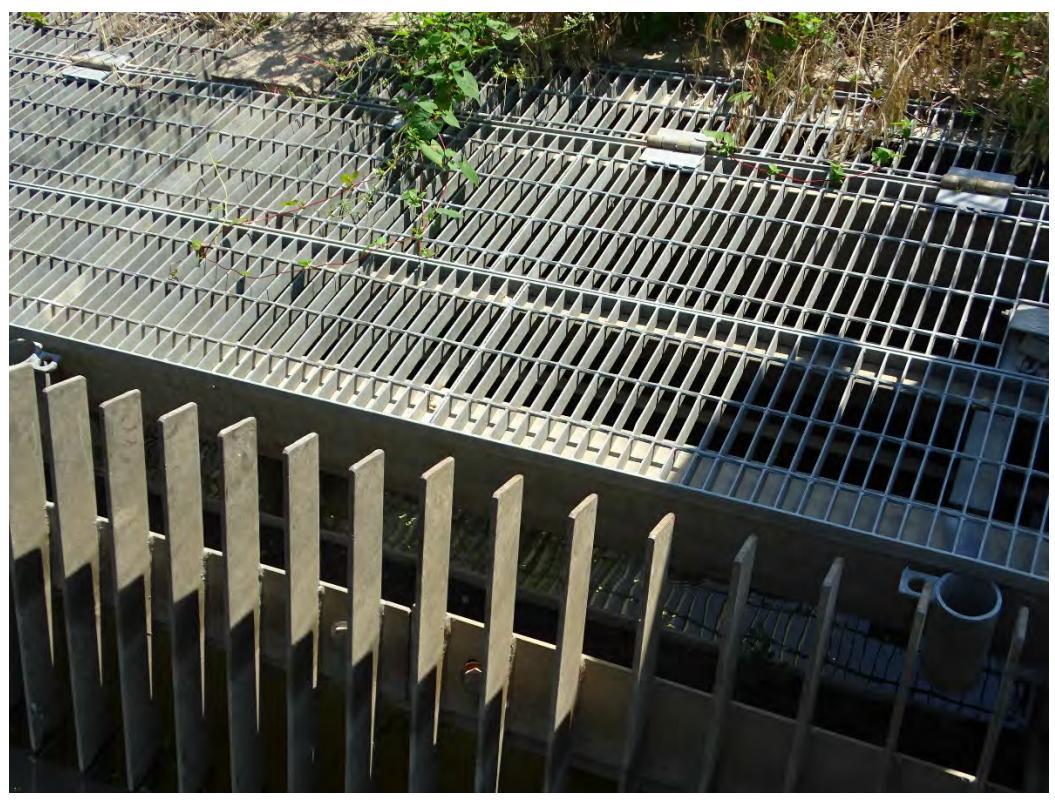
Photo 15: Gated inlet structure, interior side headwall grate

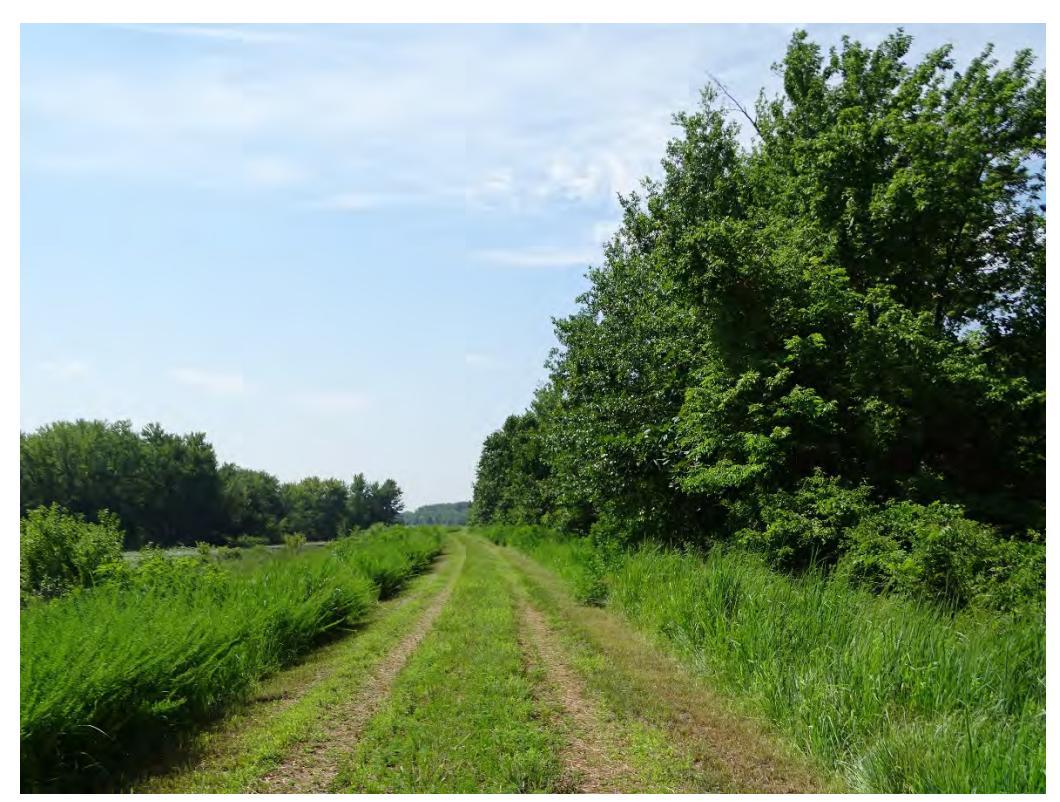
Photo 16: Perimeter levee roadway, looking south

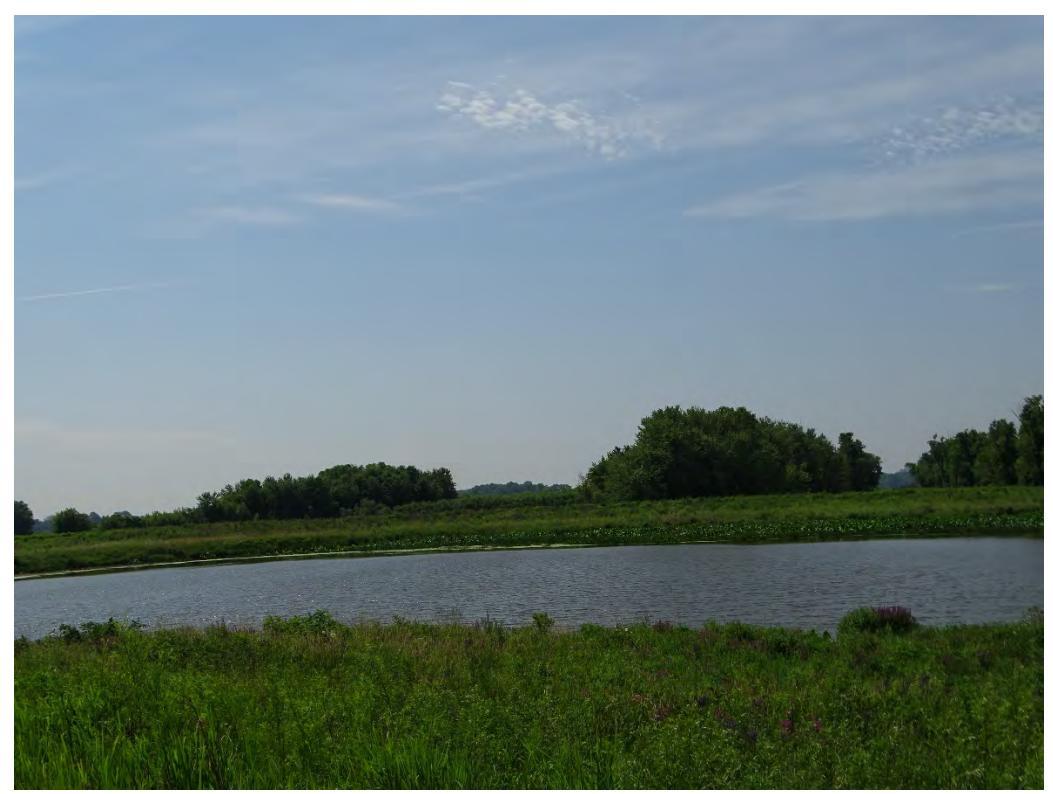
Photo 17: Setback levee on perimeter levee

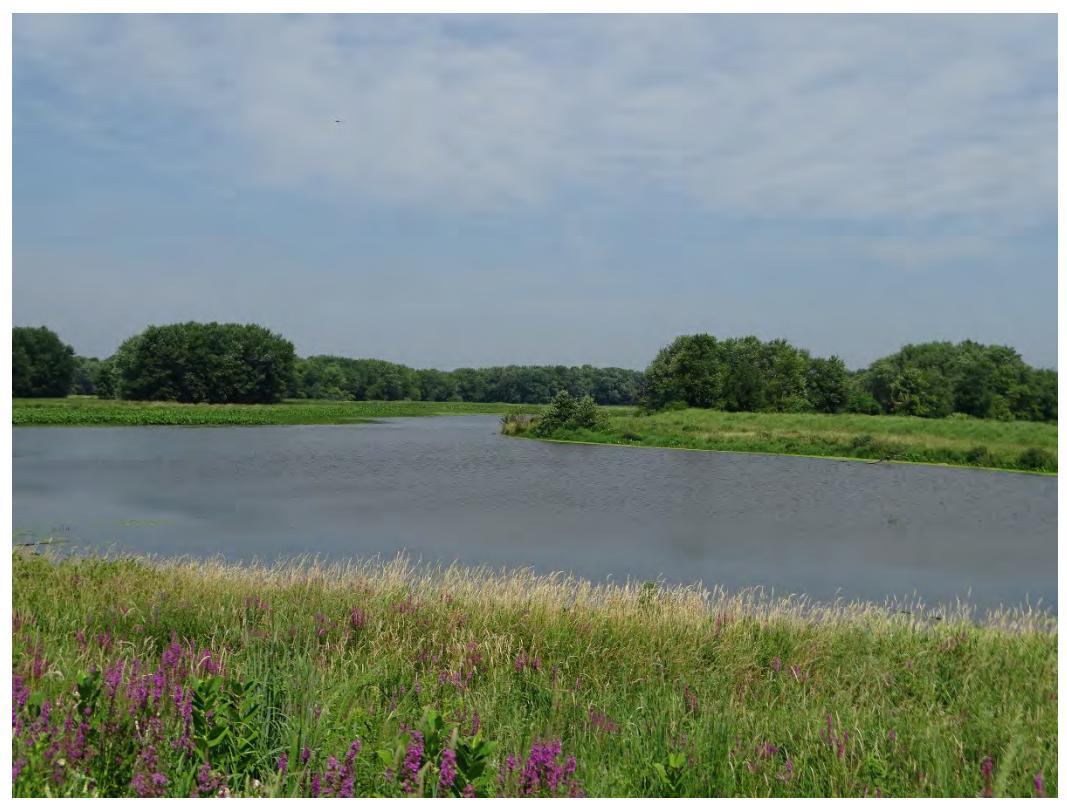
Photo 18: Setback levee on perimeter levee

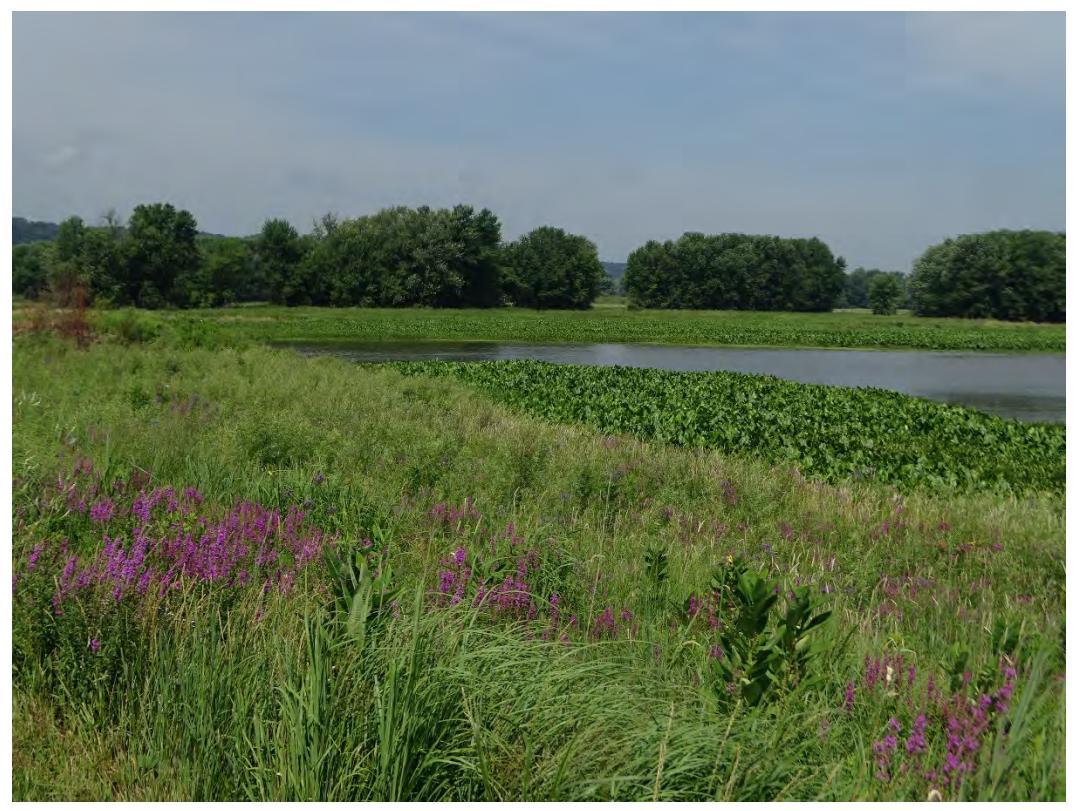
Photo 19: Perimeter levee vegetation

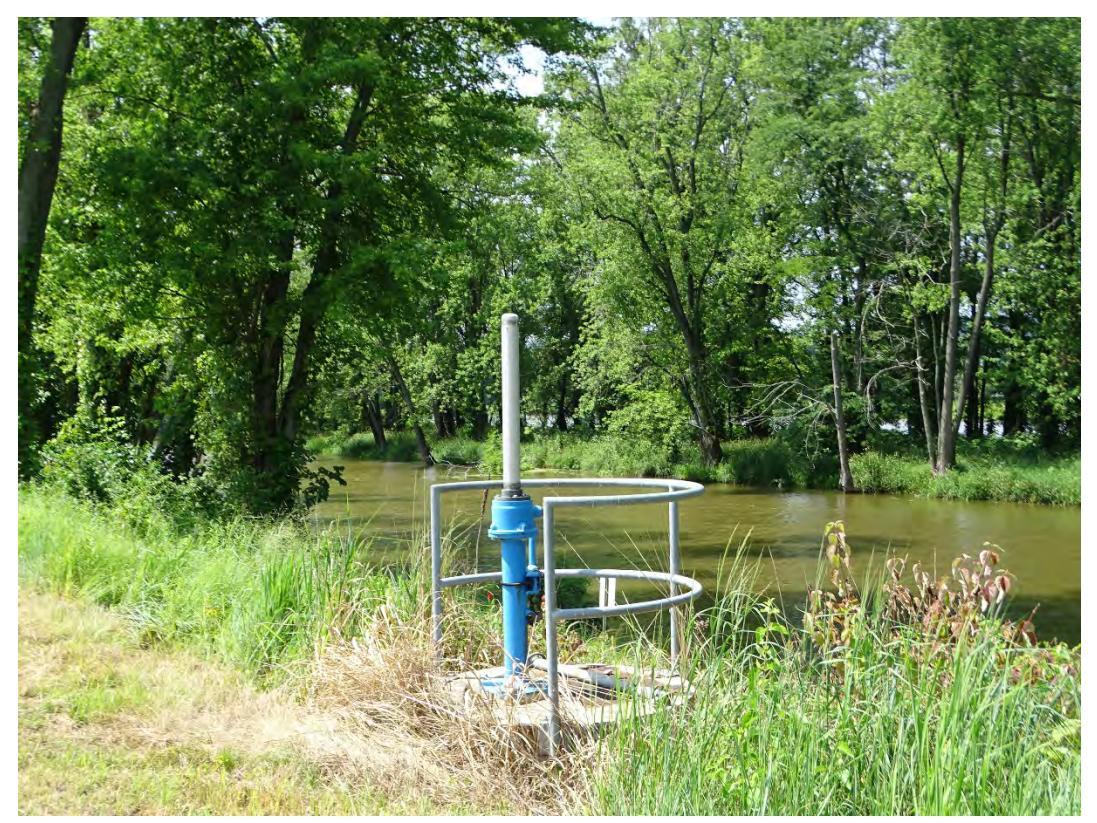
Photo 20: 24" Gatewell Structure

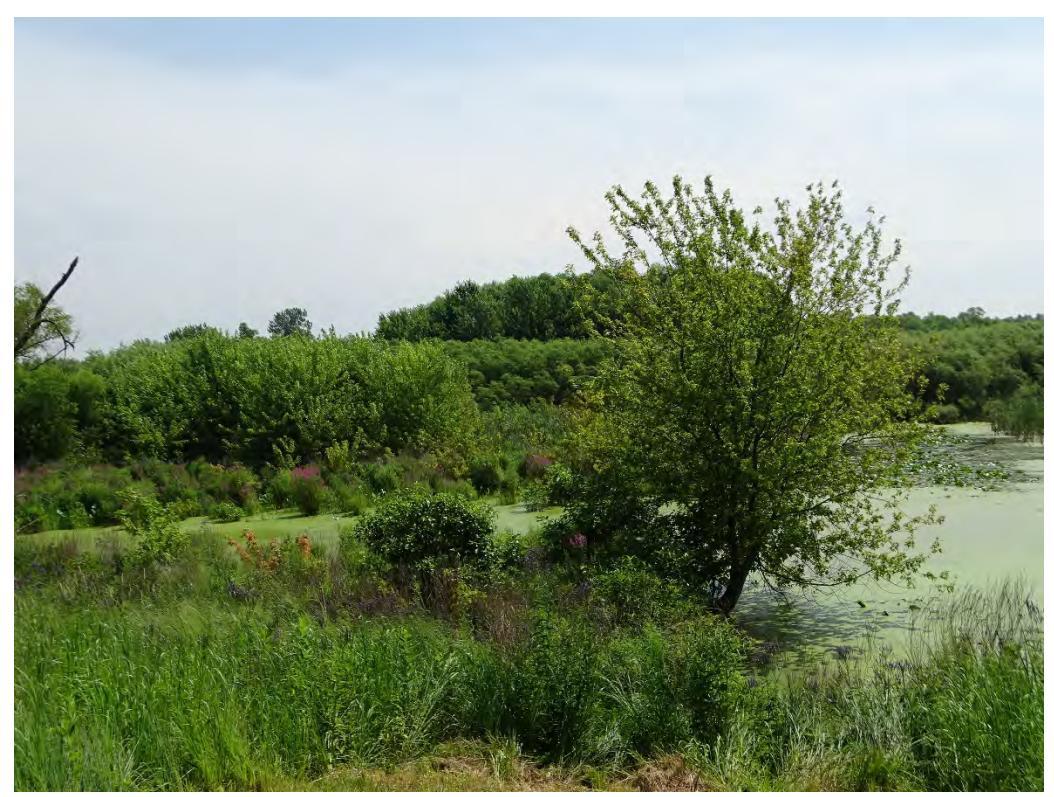
Photo 21: Spring Lake vegetation

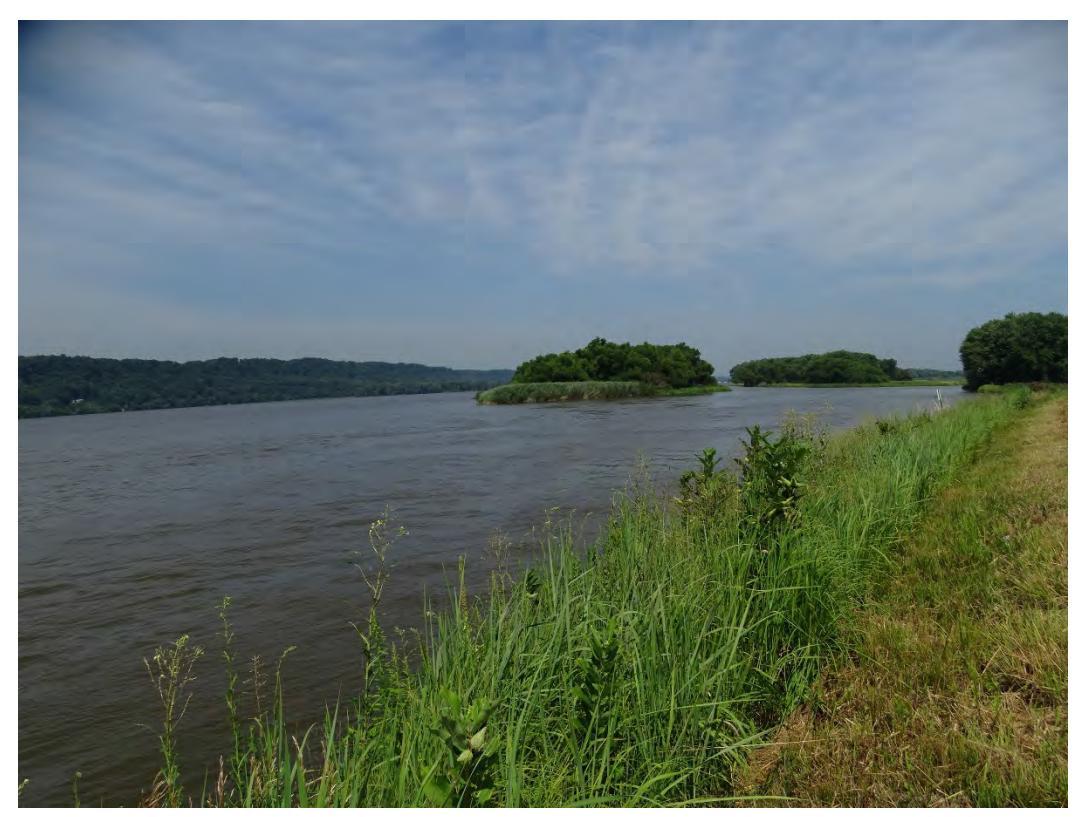
Photo 22: Perimeter levee looking upstream, riprap missing

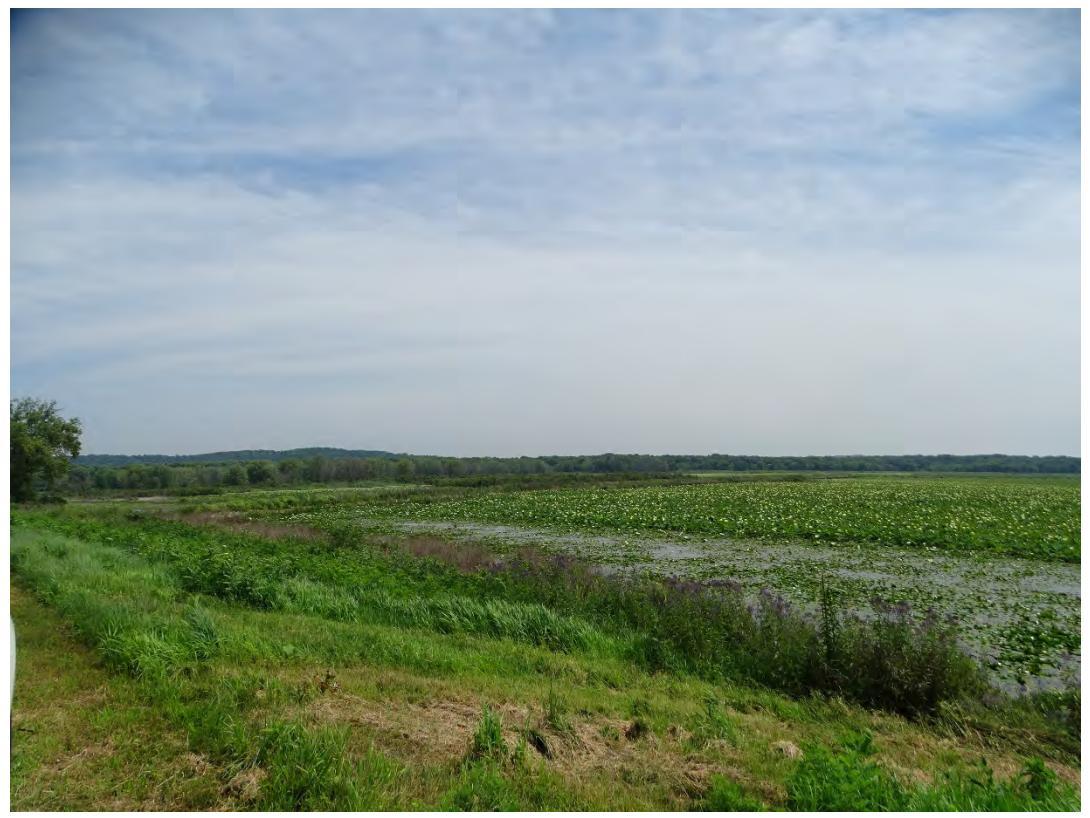
Photo 25: Interior Lower Spring Lake vegetation

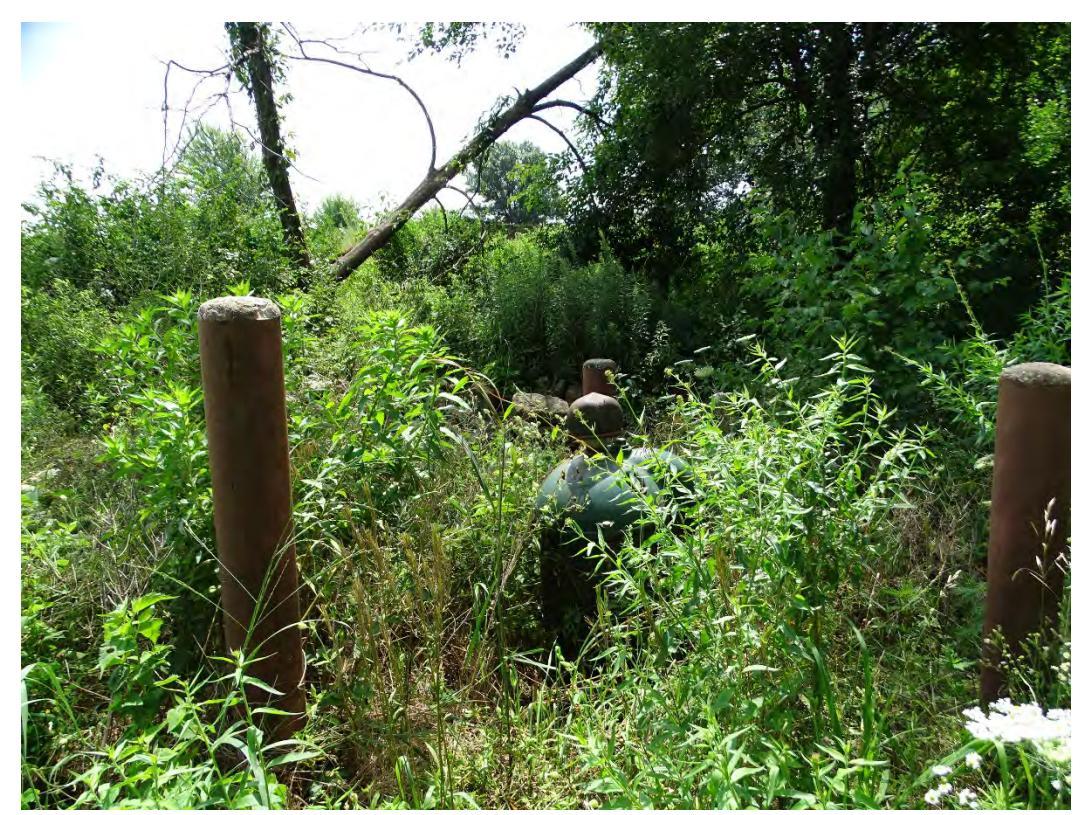
Photo 26: Hemi Marsh well

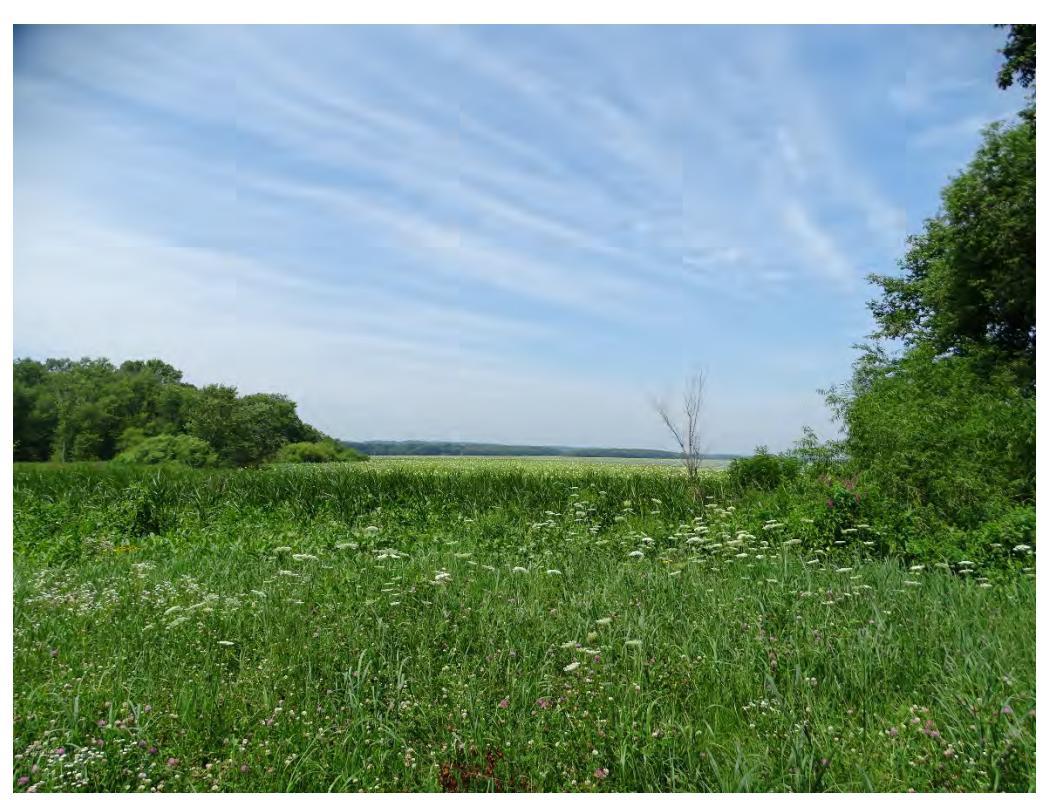
Photo 28: Lower Spring Lake from Hemi Marsh levee

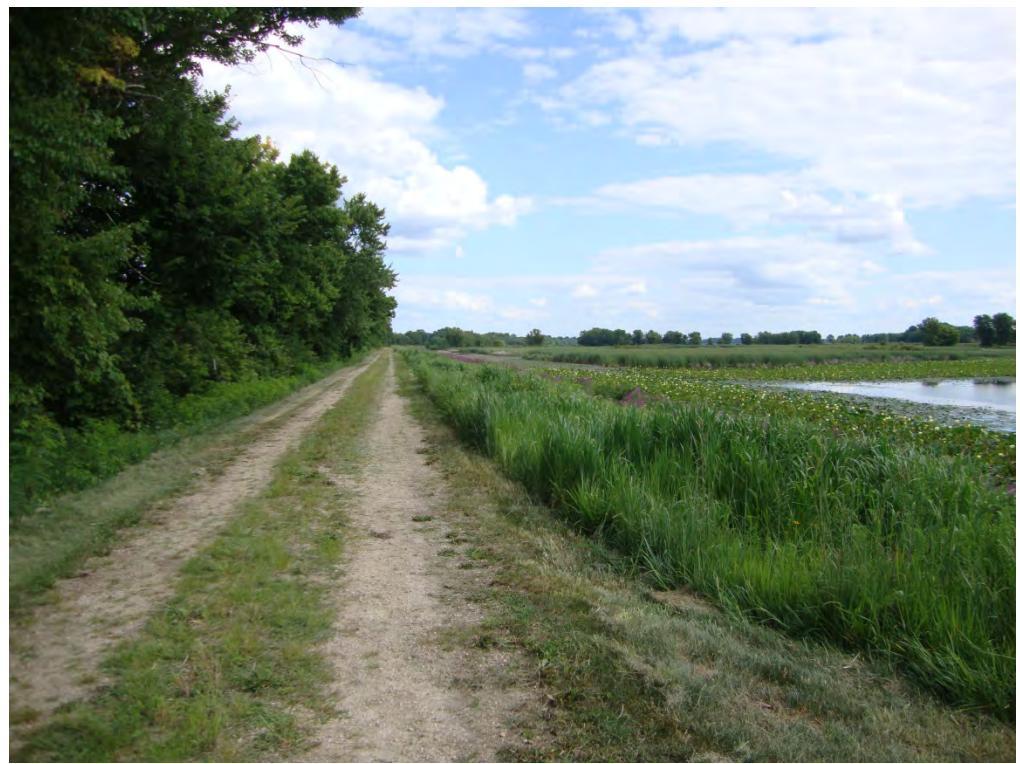
Photo 1: Perimeter Levee, east side at Interior Dike A, looking southeast.

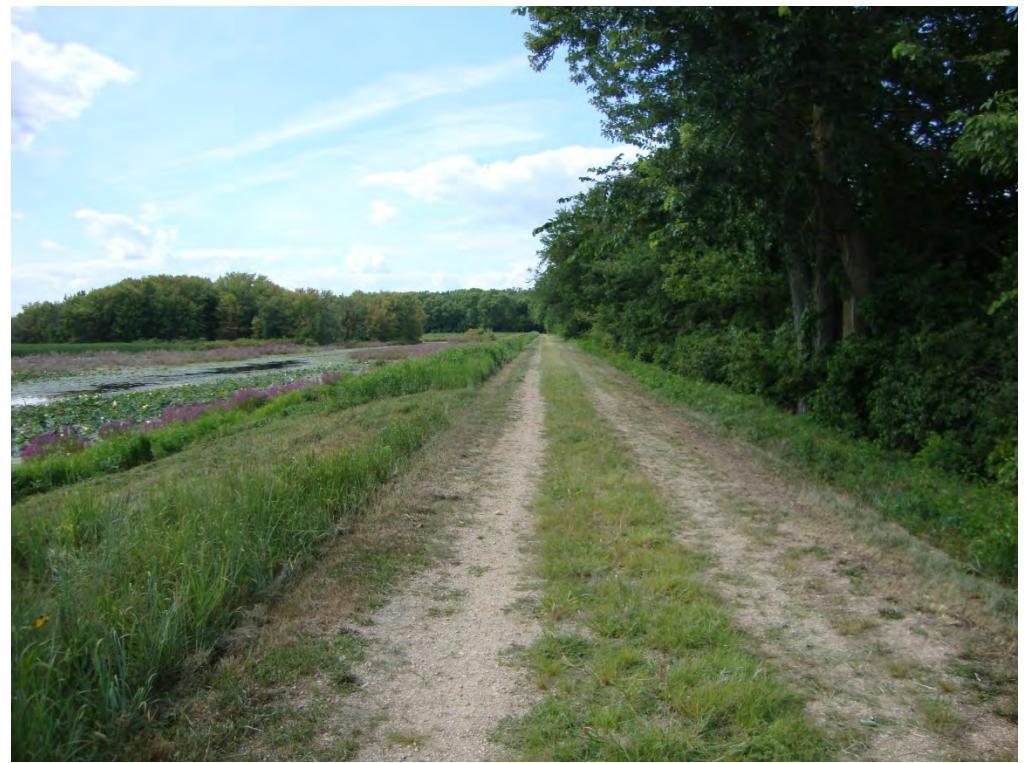
Photo 2: Perimeter Levee, east side at Interior Dike A, looking northwest.

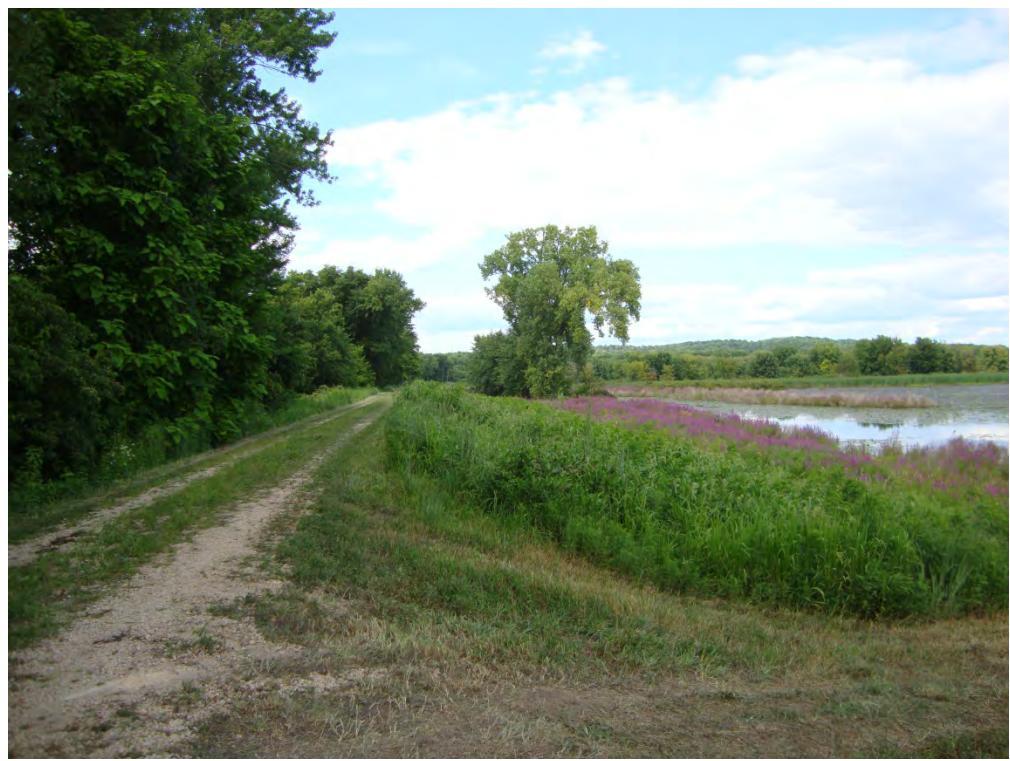
Photo 3: Perimeter Levee, west side at Interior Dike A, looking north.

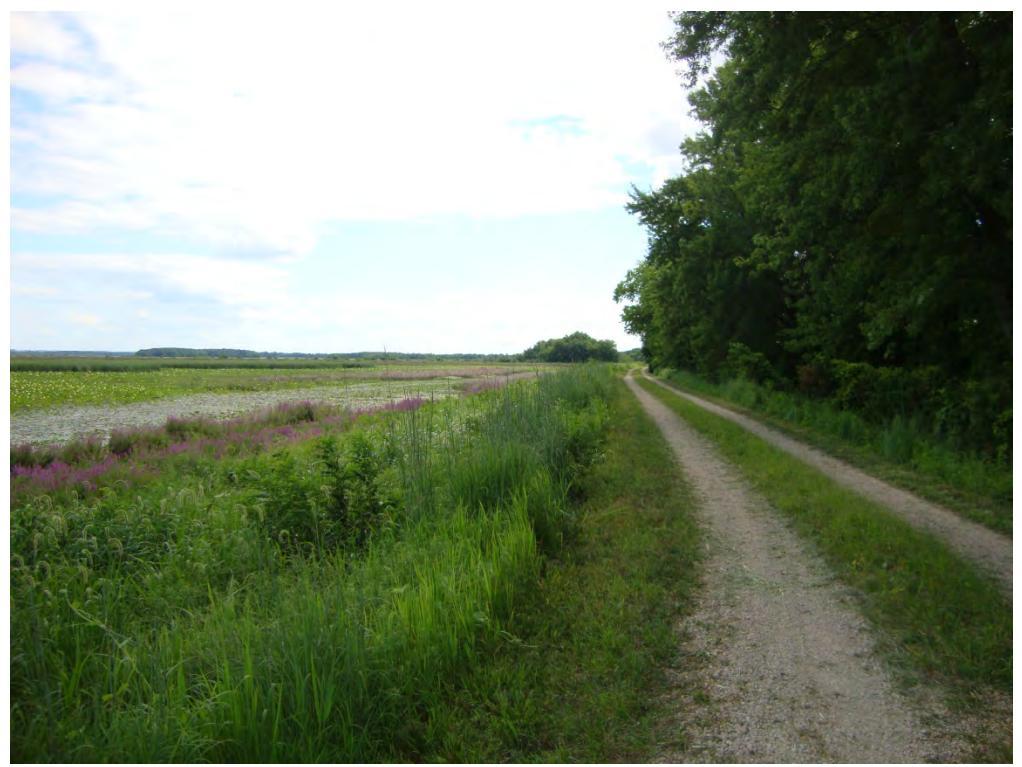
Photo 4: Perimeter Levee, west side at Interior Dike A, looking south.

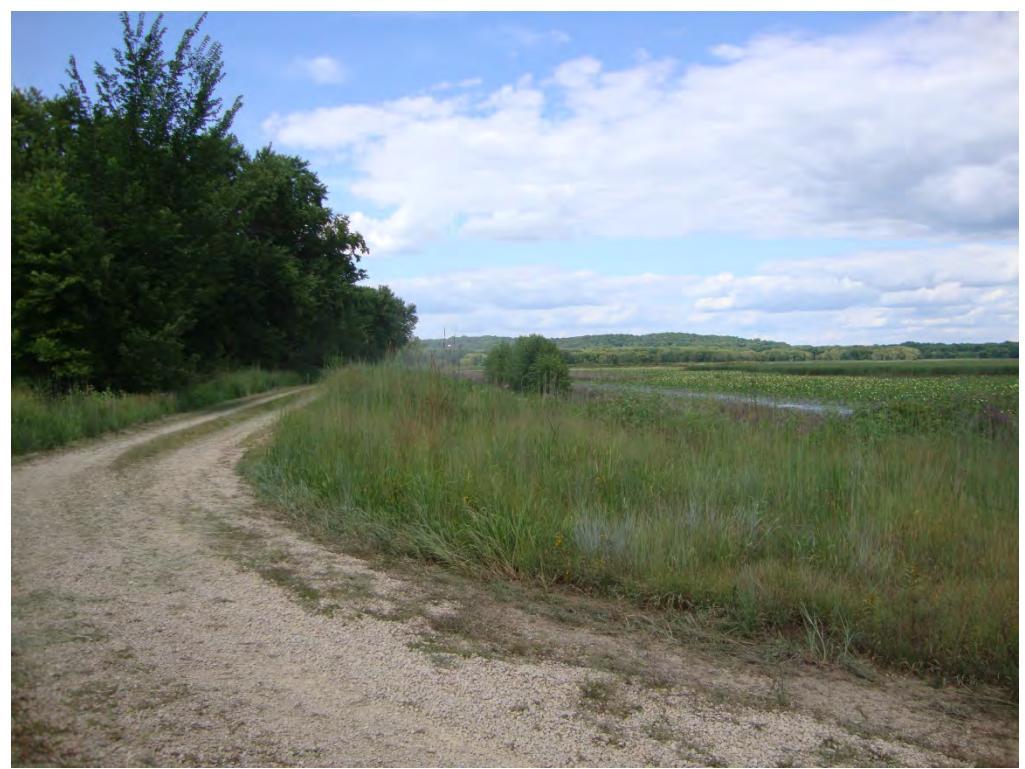
Photo 5: Perimeter Levee, west side at Cross Dike, looking north.
