UMRR HREP INSPECTION OF COMPLETED WORKS 2016

Spring Lake Habitat Rehabilitation and Enhancement Project (HREP)

Pool 13, Mississippi River Miles (RM) 532.5 to 536.0, Carroll County, IL

2013 Annual Inspection Report

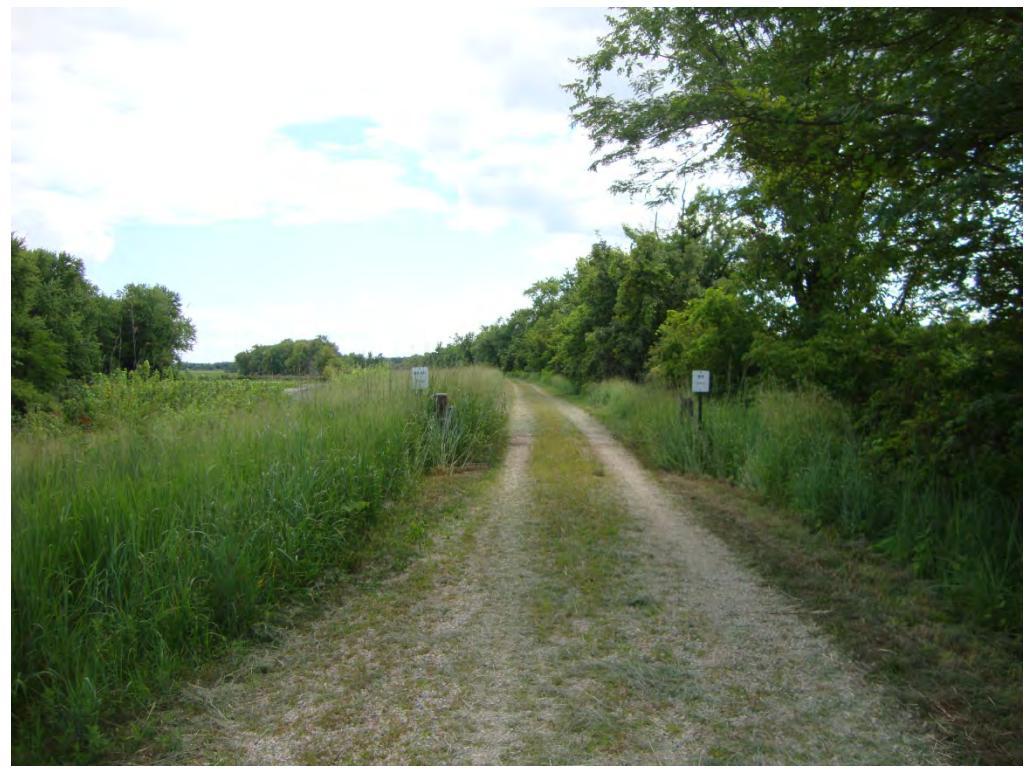
Photo 6: Perimeter Levee, west side at Cross Dike, looking south.

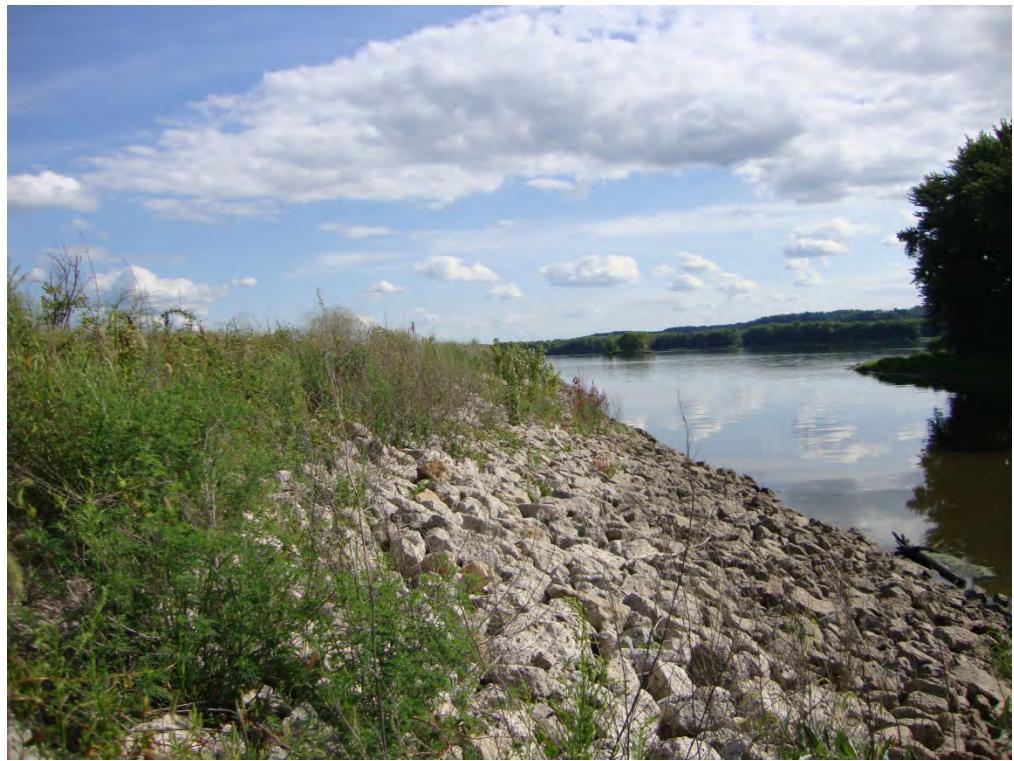
Photo 7: Perimeter Levee, 2009 erosion repair, upper end looking south.

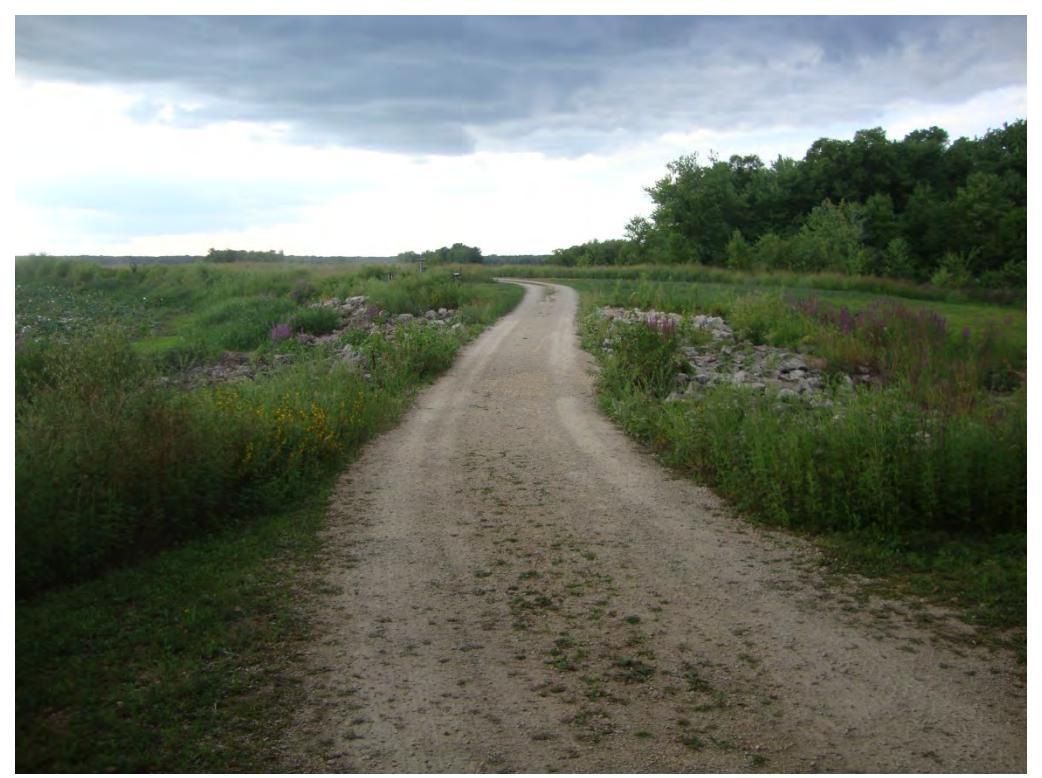
Item	Observations/Condition	Remarks/Recommendations
Entrance Area	Previously repaired area ok. Some	Continue to keep woody vegetation
Spillway	aggregate moves off road into	off spillway.
	river during flood events. Photos	
	9-10.

Photo 10: Cross Dike entrance spillway, east side looking west.

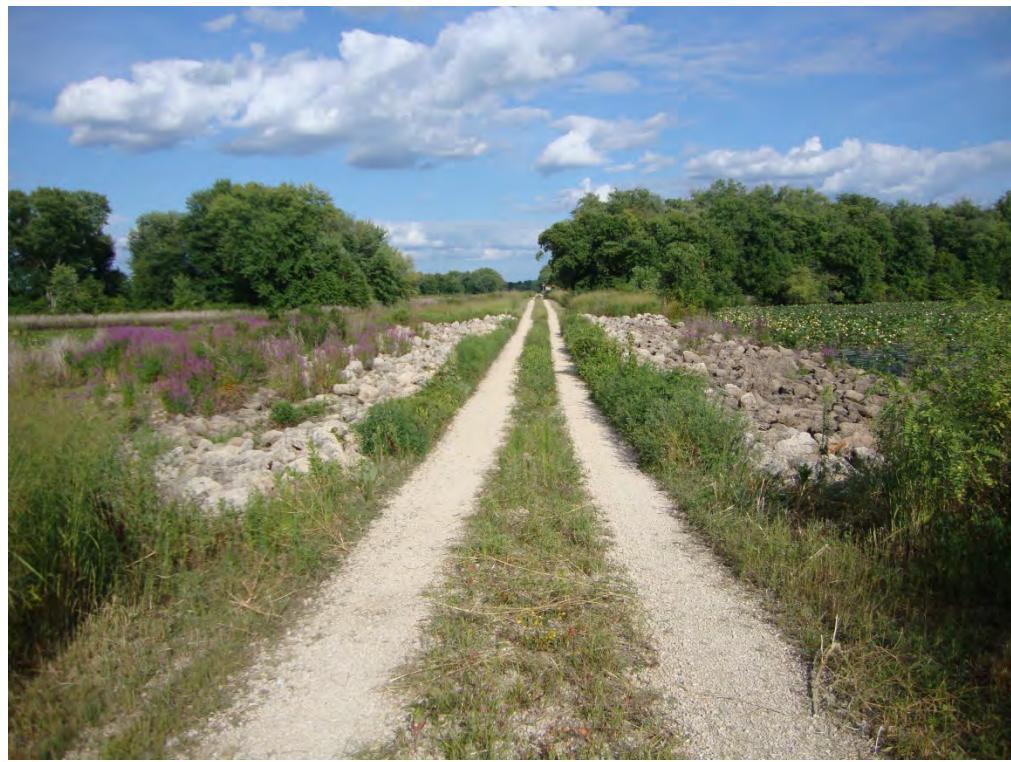
Photo 11: Cross Dike, west spillway, looking east.

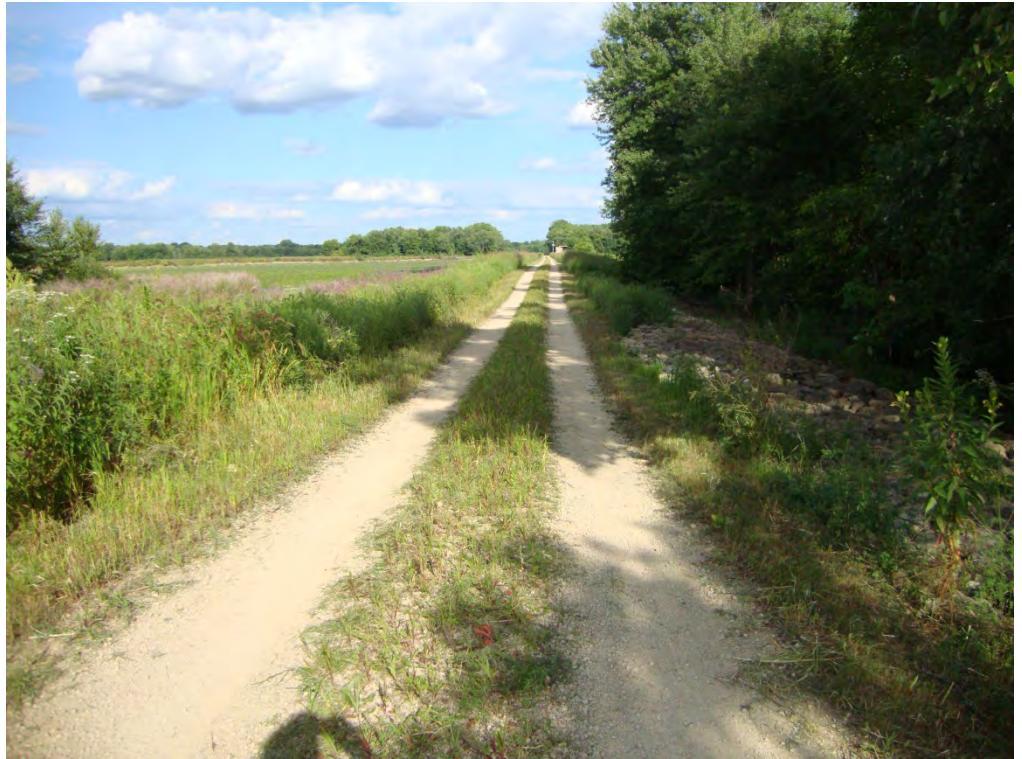
Photo 12: Cross Dike, middle spillway, looking east.

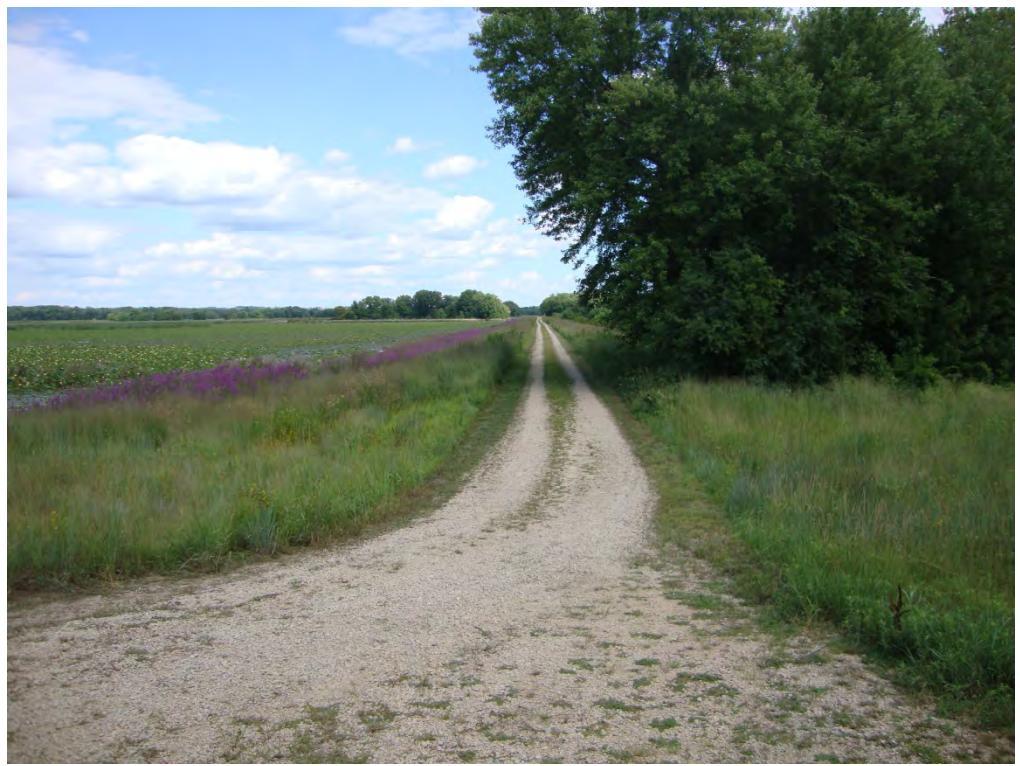
Photo 13: Cross Dike, west side at Perimeter Levee, looking east.

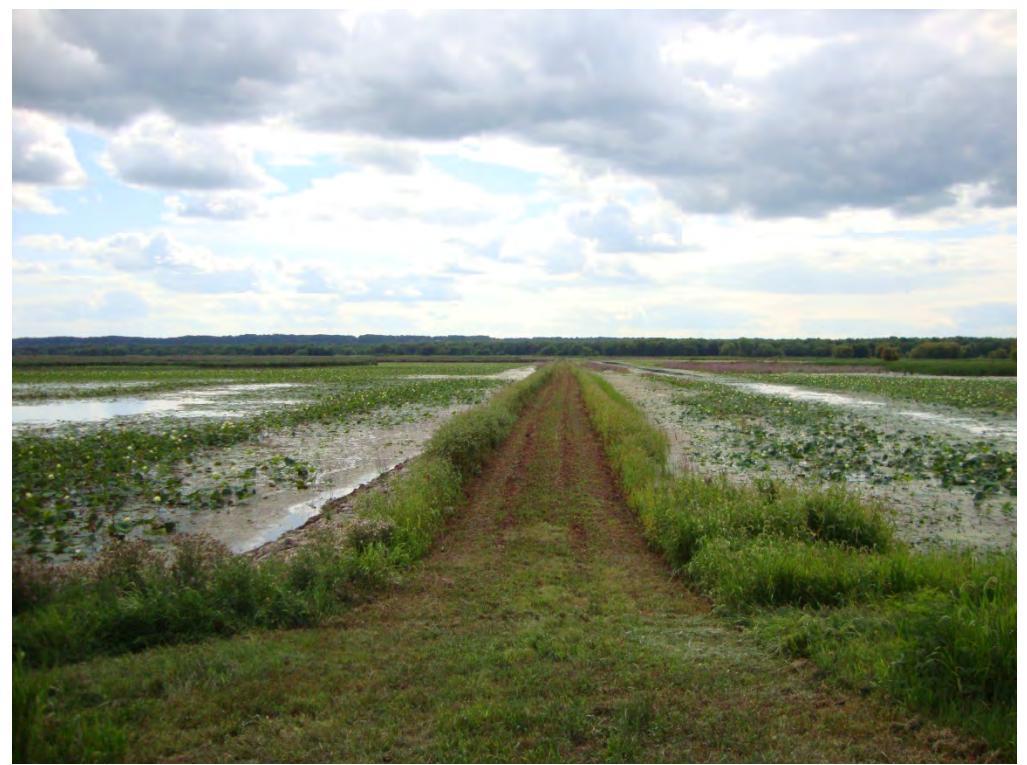
Photo 14: Interior Dike A, east end looking west.

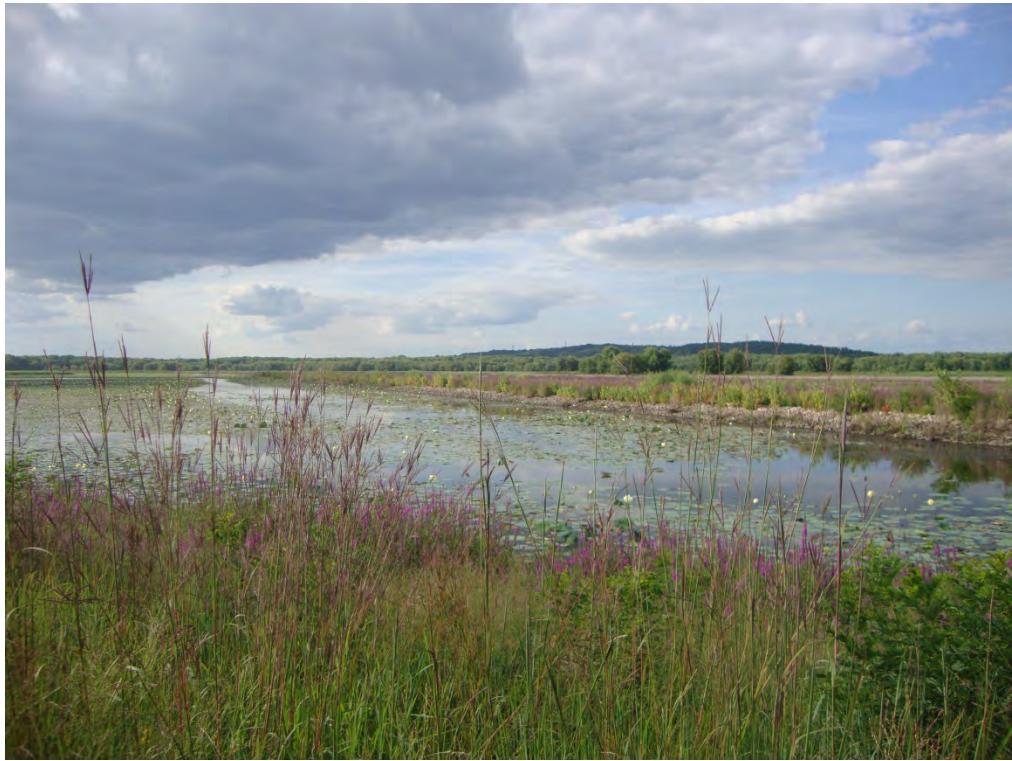
Photo 17: Interior Dike B, looking north from Cross Dike.

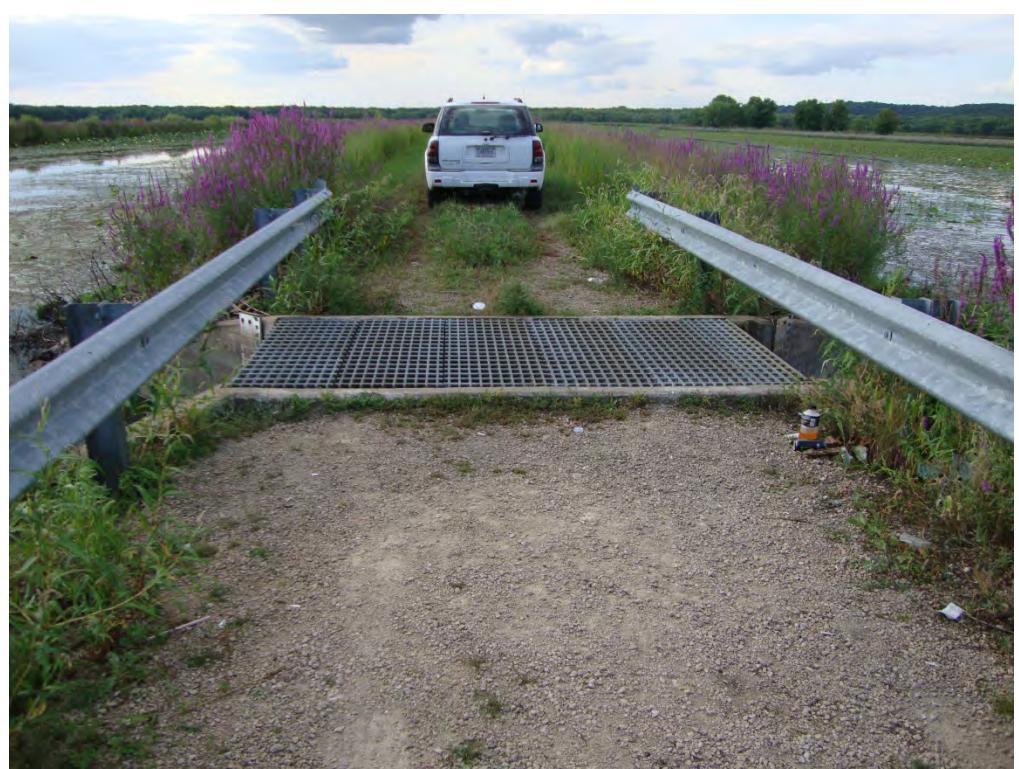
Photo 25: Stoplog Structure C, looking northwest. Regrade aggregate surfacing around the structure.

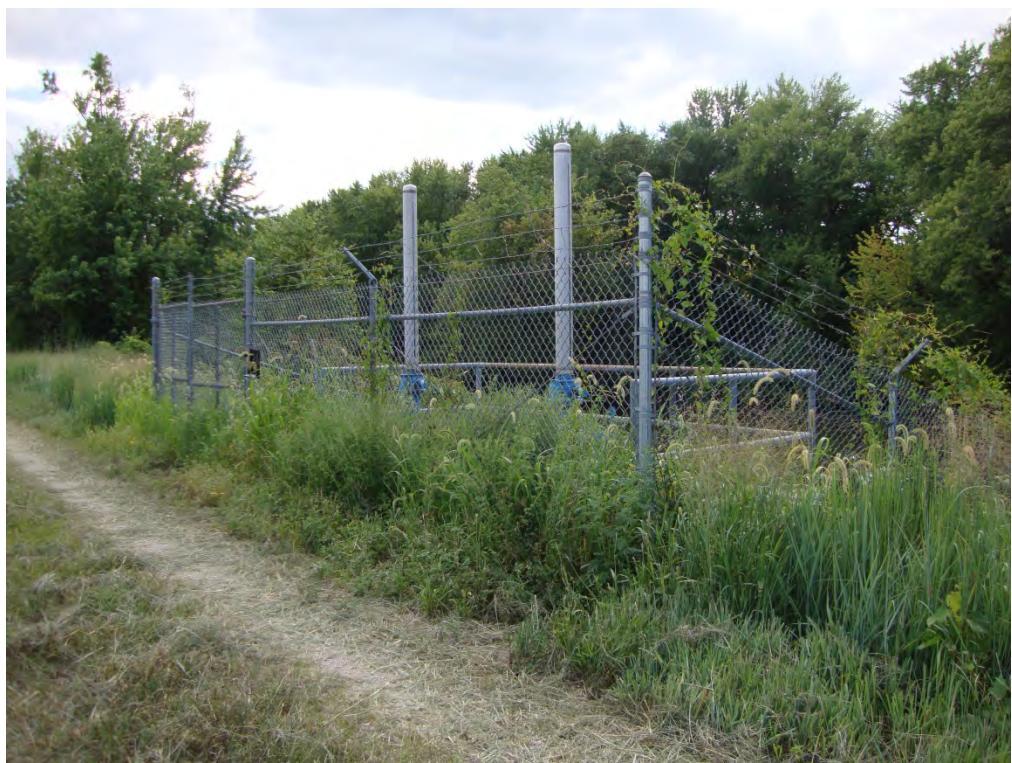
Photo 26: Gated inlet structure.

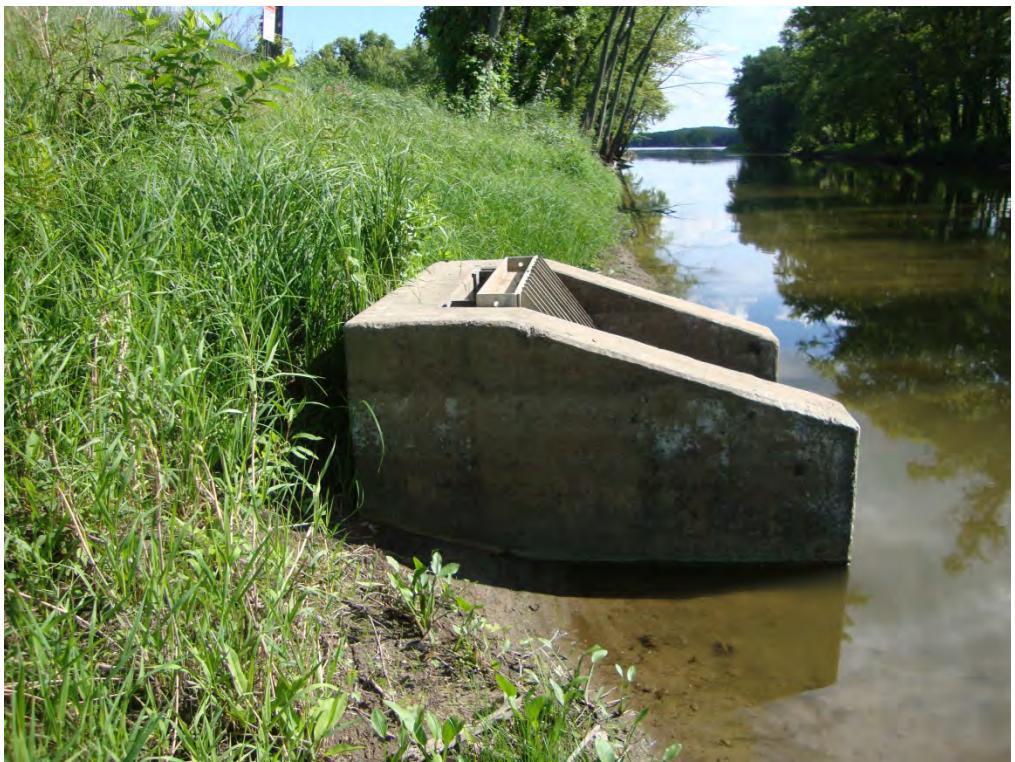
Photo 31: 24" Gatewell Structure, exterior side headwall. Minor erosion around headwall.

May be some erosion under the exterior side slab.	Continue to monitor for erosion around the structure, especially under the exterior side slab.
Stoplog Structure A	Concrete, grating, and guardrail in good condition. Stoplogs installed on Cell A side. Photo 24.	Continue to monitor. Inspect stoplogs next time resetting stoplogs.
Stoplog Structure B	Concrete, grating, and guardrail in good condition. No stoplogs installed.	Continue to monitor. Inspect stoplogs next time resetting stoplogs.
Stoplog Structure C	Aggregate surfacing at grating interface is low.	Regrade aggregate surfacing at grating.
	Concrete, grating, and guardrail in good condition. Photo 25.	Continue to monitor. Inspect stoplogs next time resetting stoplogs.
Existing Gatewell Structure STA 122+84	Good condition. Did not check operation.	Continue to monitor.

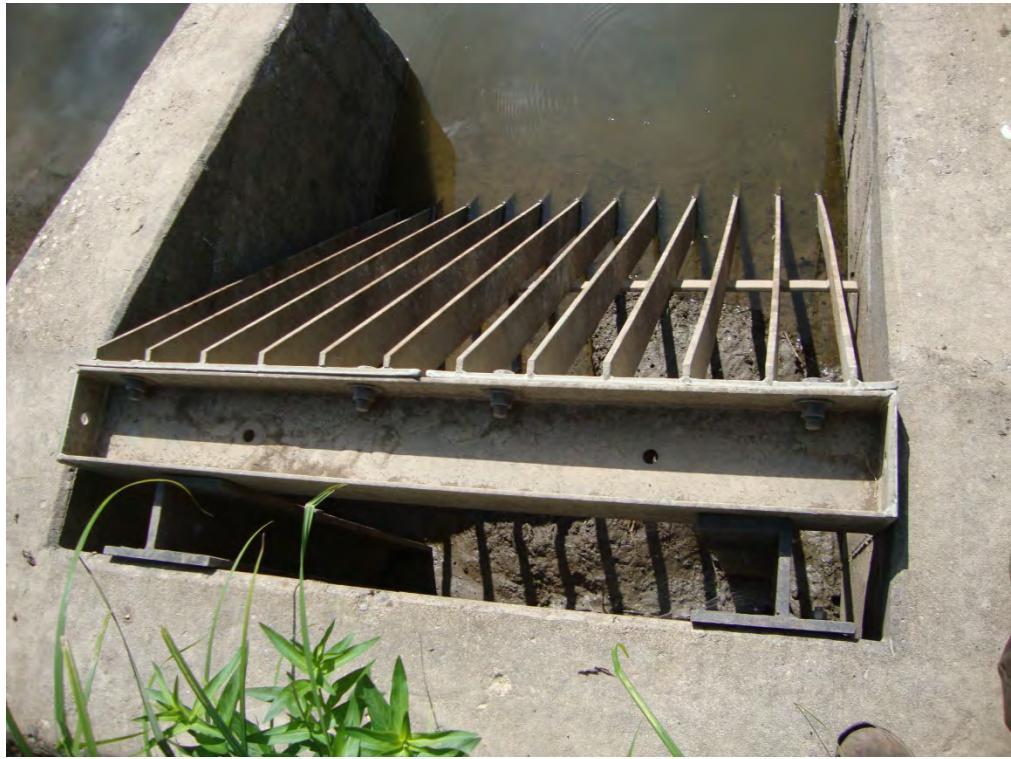
Photo 32: 24" Gatewell Structure, exterior headwall grating.

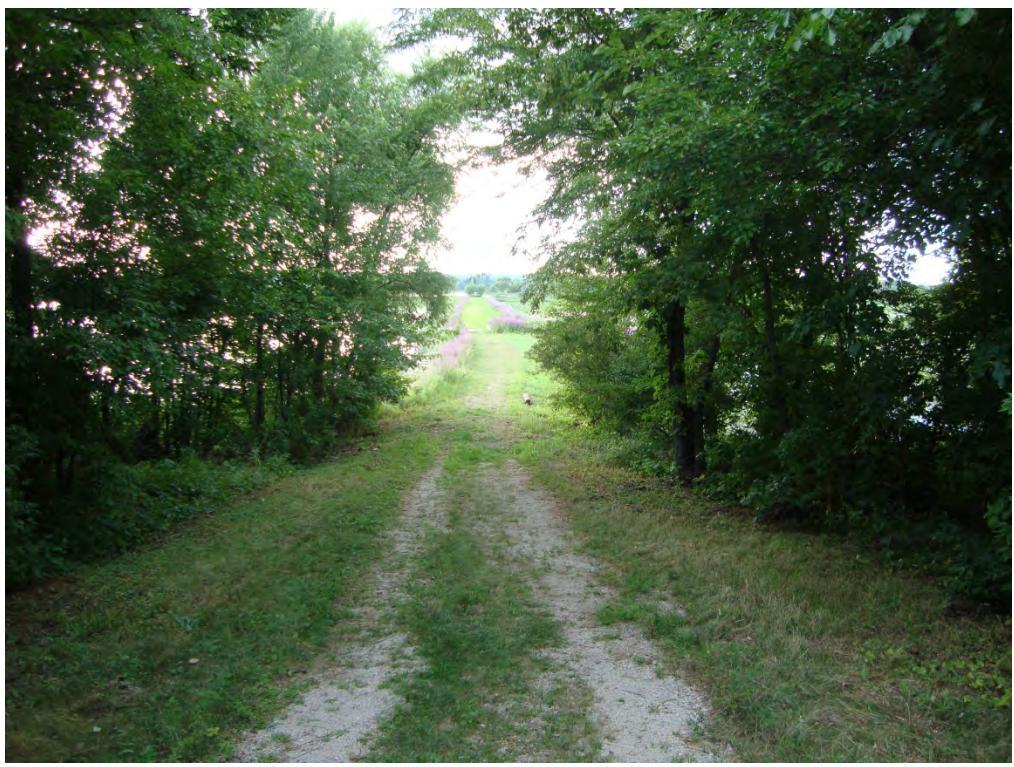
Photo 34: Hemi Marsh Levee, south gate looking west.

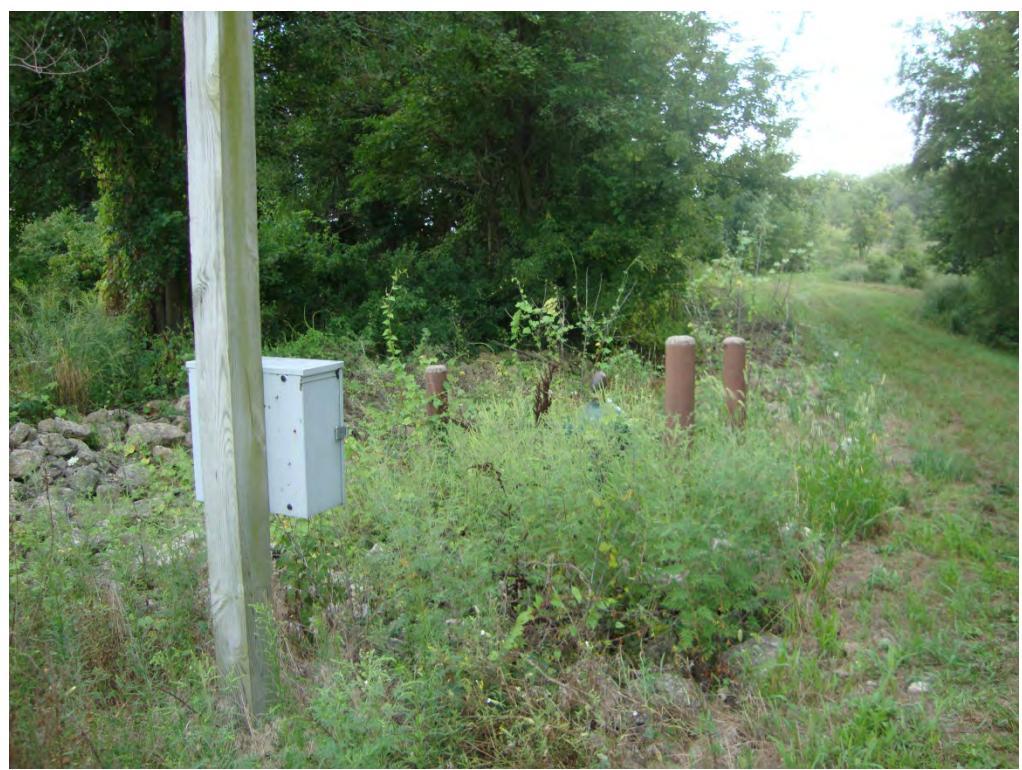
Photo 37: Hemi Marsh well area, looking west.
